Industrial Storm Water Pollution in Wolf River Harbor

April 2003

Water Sentinels Campaign
April 2003

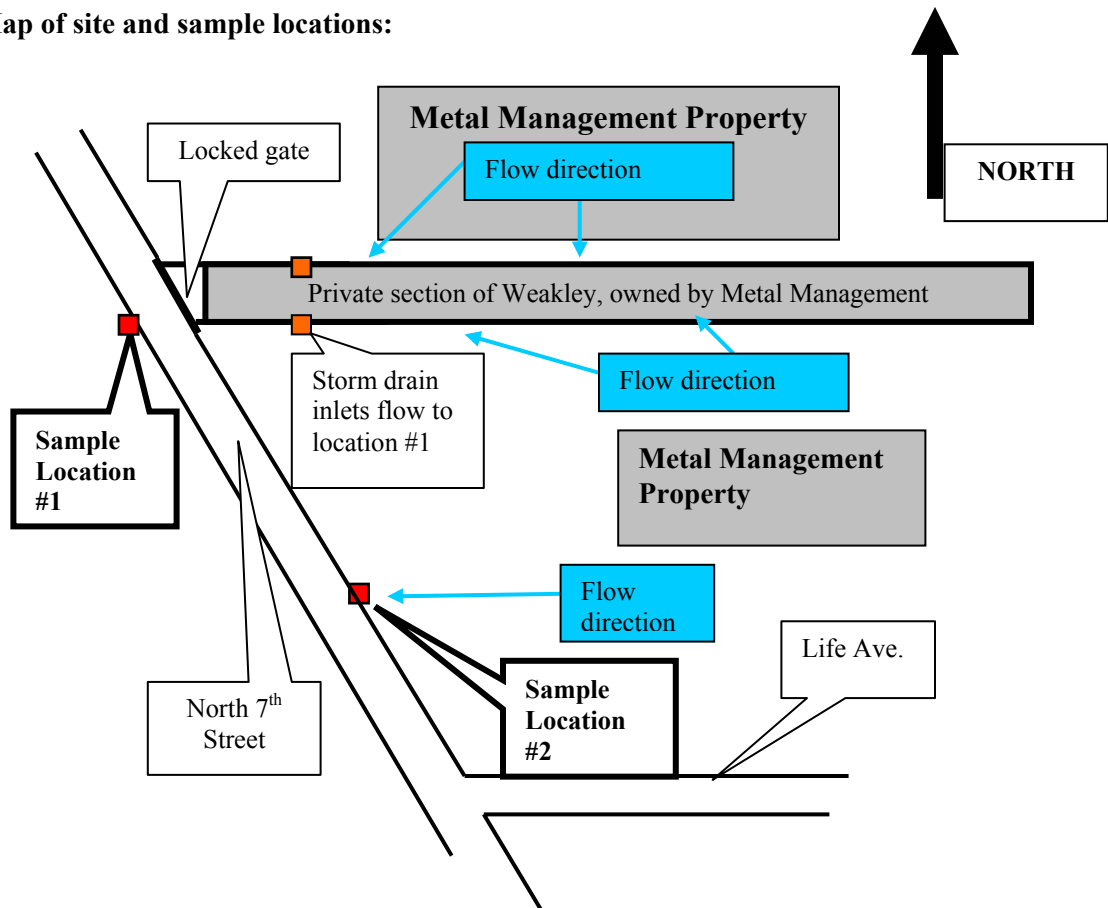
Map of site and sample locations:

Location #1: is pipes discharging from a "headwall" on the west side of North 7th St. at Weakley Ave. This location does appear to have some off-site water that would dilute the discharge from Metal Management. However, to avoid trespassing onto the site, and to collect the most representative sample of the runoff from the north and south side of Weakley, this site was chosen.

Location #2: is at the facility's fence-line in a ditch on the easternmost side of North 7th that conveys storm water off the Metal Management site. The nearest address is 1270 North 7th St. This location is unaffected by off-site water.

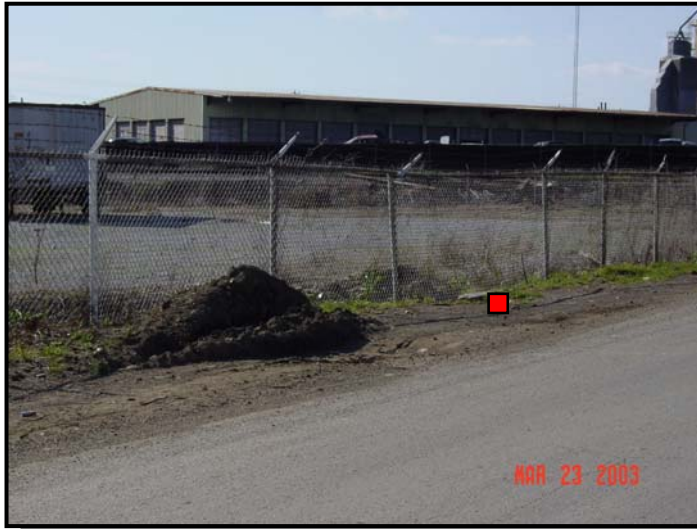
Sample Location #1

(Top) Location #1 is red square. Pipes discharge from a “headwall” on the westernmost side of North Seventh St. at Weakley Ave.

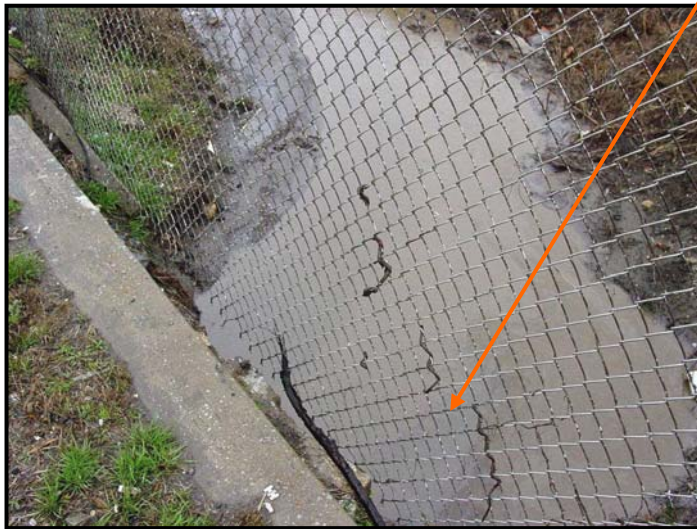
(Bottom Left) Close up photograph of this headwall with storm water runoff from Metal Management facility. Note the oil sheen on the water (orange arrow).

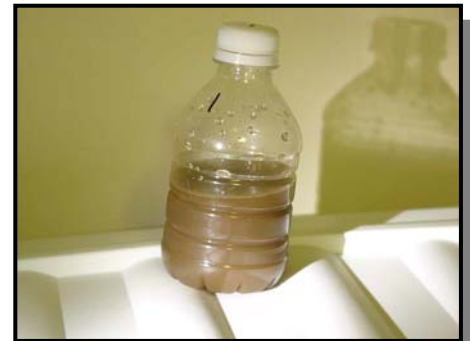
Chemical Analyses and “Cut-off Concentration”	Result – mgs/L
Total Suspended Solids – 200mgs/L	1,860
Chemical Oxygen Demand – 120mgs/L	984
Total Recoverable Aluminum – 0.75mgs/L	60.3
Total Recoverable Copper – 0.0636mgs/L	2.13
Total Recoverable Iron – 5.00mgs/L	222
Total Recoverable Lead – 0.156mgs/L	3.16
Total Recoverable Zinc – 0.395mgs/L	14.0
Visual Analyses	Result
Color	Dark brown-gray
Odor	Odor of oil
Clarity	Opaque
Floating Solids	Present
Settled Solids	Present: Some reacted to a magnet
Suspended Solids	Present
Foam	None observed
Oil Sheen	Present
Other storm water pollution indicators	None observed

(Bottom Right) Sample of this runoff.

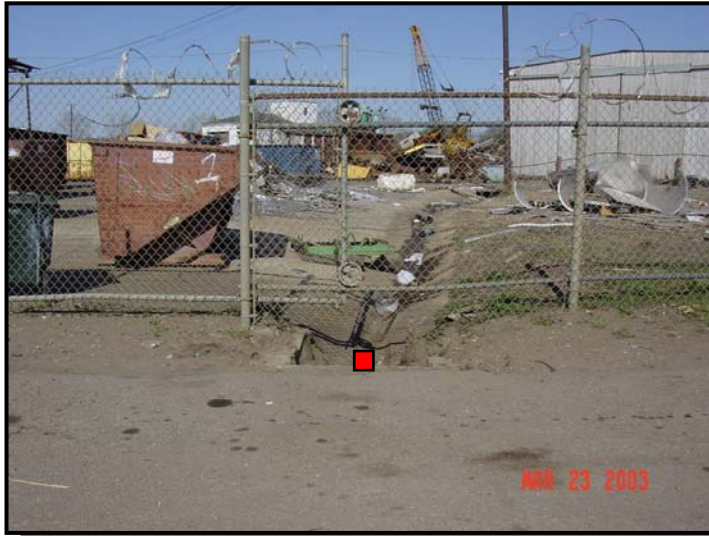
Sample Location #2

(Top left) Location #2 is red square at the facility's fence-line in a ditch on the easternmost side of North Seventh that conveys storm water off the Metal Management site. The nearest address is 1270 North Seventh St.

Note: No Best Management Practices (BMPs) are visible. Note debris in ditch.

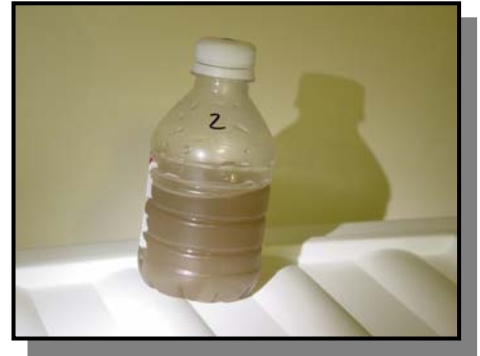
Chemical Analyses and “Cut-off Concentration”	Result – mgs/L
Total Suspended Solids – 200mgs/L	728
Chemical Oxygen Demand – 120mgs/L	803
Total Recoverable Aluminum – 0.75mgs/L	22.0
Total Recoverable Copper – 0.0636mgs/L	6.33
Total Recoverable Iron – 5.00mgs/L	57.2
Total Recoverable Lead – 0.156mgs/L	4.29
Total Recoverable Zinc – 0.395mgs/L	3.58
Visual Analyses	Result
Color	Brown-gray-slightly lighter in color than #1 above
Odor	Odor of oil
Clarity	Opaque
Floating Solids	None observed
Settled Solids	Present: Some reacted to a magnet
Suspended Solids	Present
Foam	None observed
Oil Sheen	Present
Other storm water pollution indicators	None observed

(Top right) Sample of this runoff.

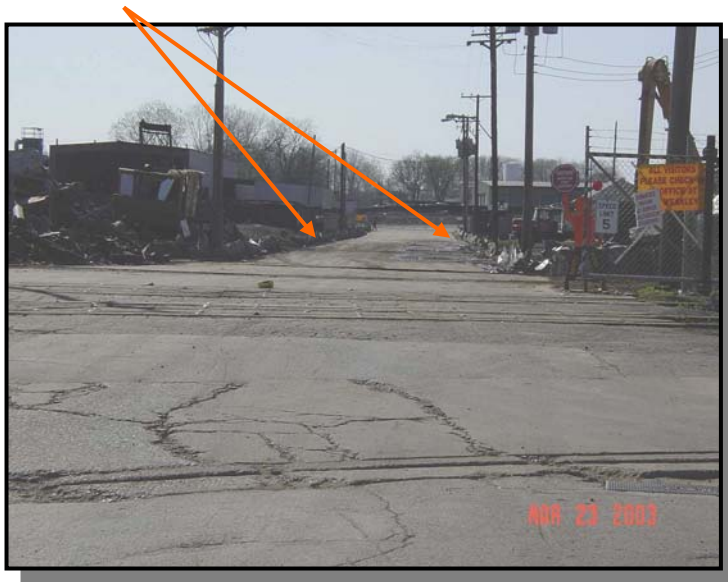
Metal Management: On the privately owned section of Weakley, silt fence and hay bales have been installed. However, it appears that the installation and maintenance of these Best Management Practices (BMPs) are ineffective. In a majority of the silt fence sags and gaps can be seen. Mud was observed in the easternmost part of the private section of Weakley. Junk metal parts and large piles of various metals are on the property on both sides of Weakley. Any pollutants from this section of the property will migrate to Sample Location #1 in the stormwater runoff. On the Metal Management property near 1270 North 7th St., there were no BMPs visible. Large piles of various metals are on site, including a large pile of car and truck radiators. Any pollutants from this section will migrate to Sample Location #2 in the stormwater runoff.

(Bottom) **Metal Management:** A view of Best Management Practices (BMPs): Photo from public section of Weakley. One can see sagging silt fence (the BMP) and dirt in the street (orange arrows). Stormwater from this section flows to Sample Location #1.

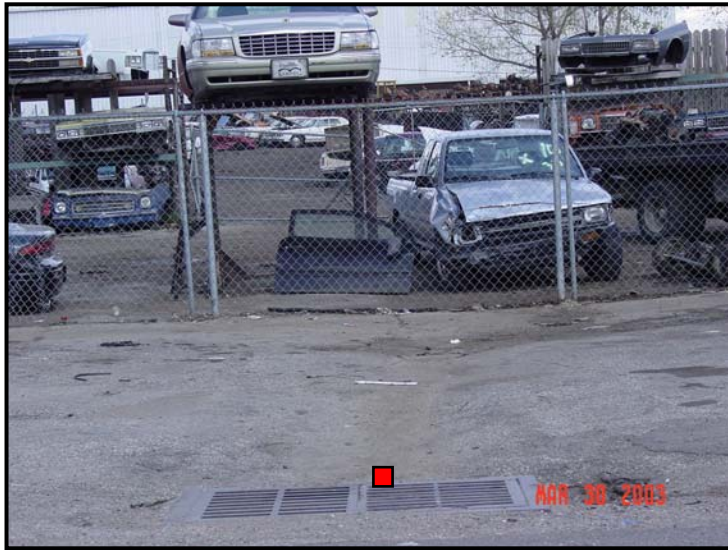
Levee Auto Parts and Salvage at 1336 North Second Street. No file was located at TDEC on this facility.

Levee Auto Parts and Salvage: In area that is serviced by the outfall sampled, cars and car parts are on racks and the ground. There are no BMPs visible. A solid metal fence prevents observation for BMPs at the other two outfalls near North Second St.

Note: No Best Management Practices visible.

Sample location is red square at edge of North Second St.
