From: Pomajzl, Mark
Sent: Thursday, March 18, 2021 2:28 PM
To: Pracheil, Brad; Anderson, Reuel; Ugai, Susan; Stoll, Hillary; Valentine, Kara; Goans, Steve; Windhorst, Jason
Subject: AltEn Site visit (Wednesday)
Attachments: AltEn daily (wednesday).docx

Facility: AltEn
IIS: 84069
PCS: NE0137634

Mark Pomajzl
3-17-2021

Site Visit Check list

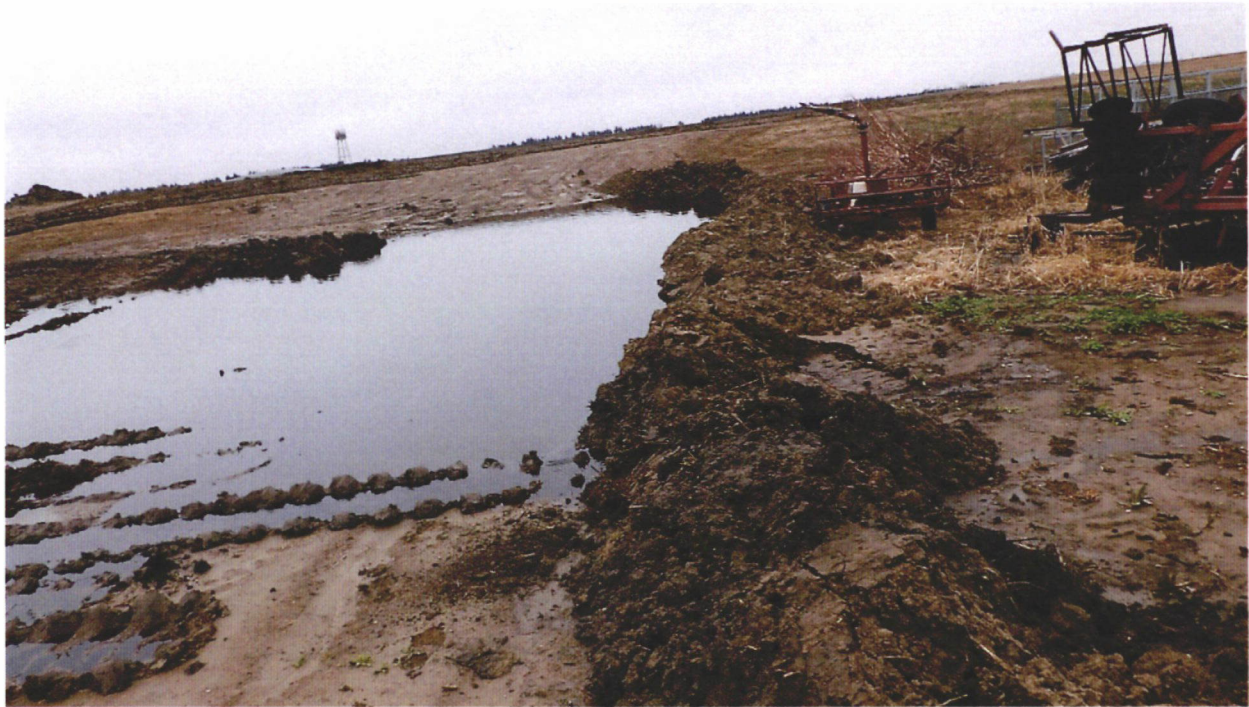
Photo: 1

Description: This photo depicts the area northeast of the administration building. The facility installed a berm along a low area which conveys to the southwest side of the south lagoon. The berm does not appear to be leaking.

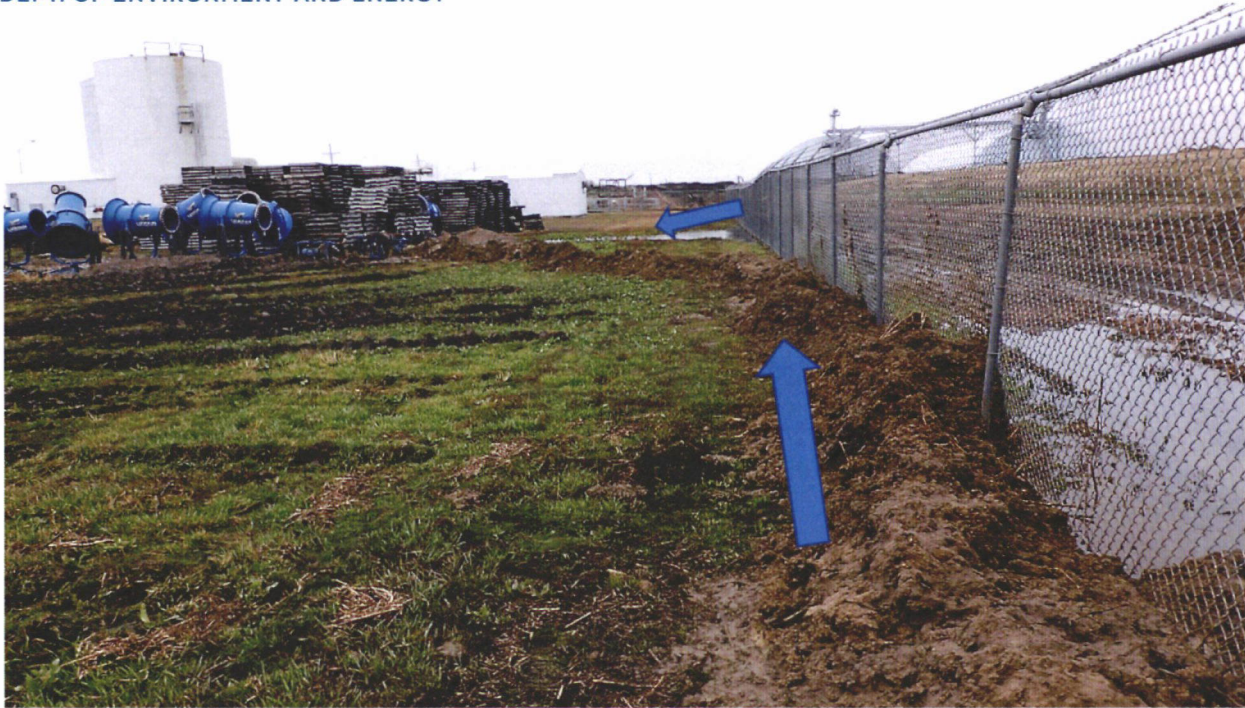
Photo: 2

Description: This photo depicts the berm southwest of the south lagoon. The facility extended the berm south and west along the fence (arrow). There is no evidence of leaking.

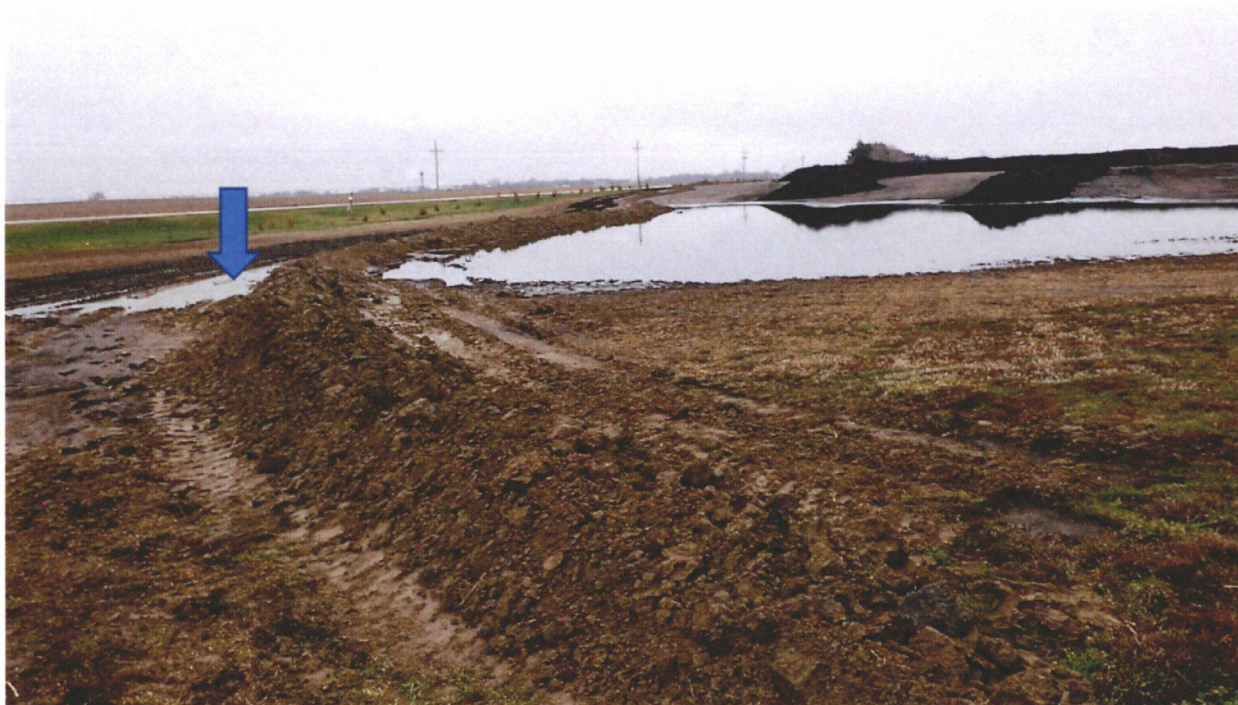
Description: This photo depicts the berms north of the hoop building. There is water contained behind the berm. The water to left appears to be rain water accumulation (arrow). I did not see evidence of leaking at this time.

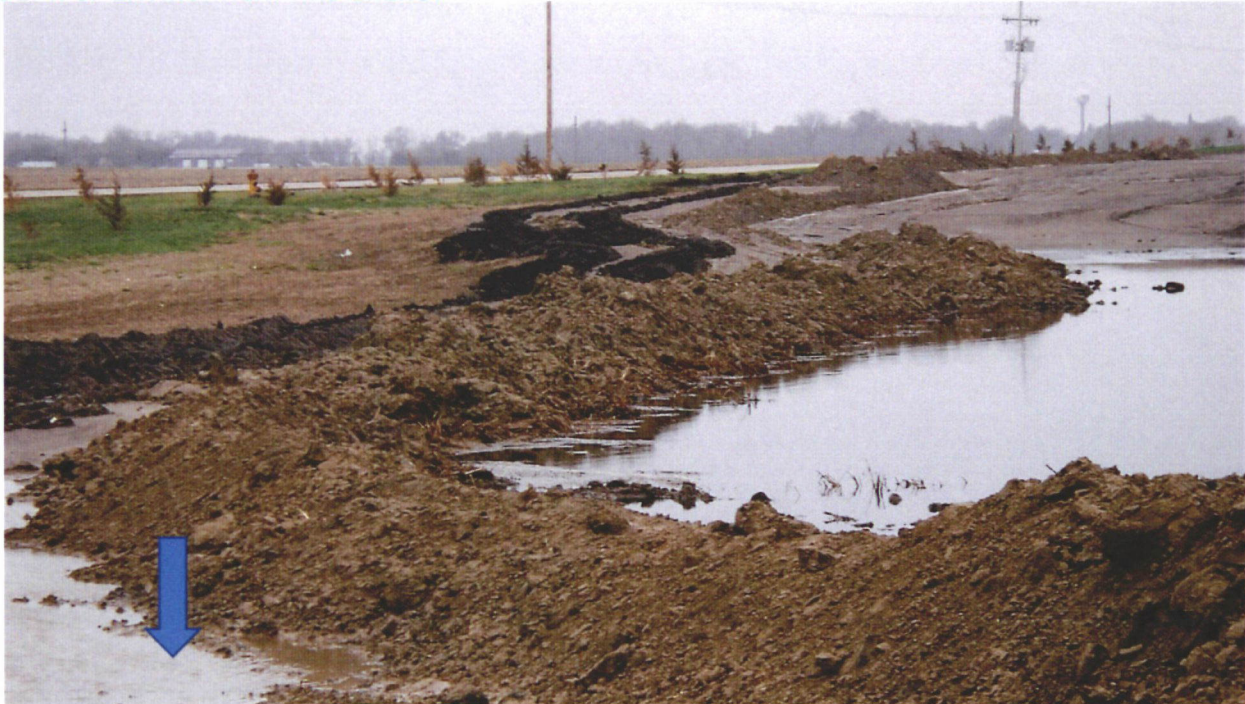
Photo: 4

Description: This is a closer photo the berm Northwest of the hoop building. There is water contained behind the berm. The water to left side appears to be rain water accumulation (arrow). I did not see evidence of leaking at this time.

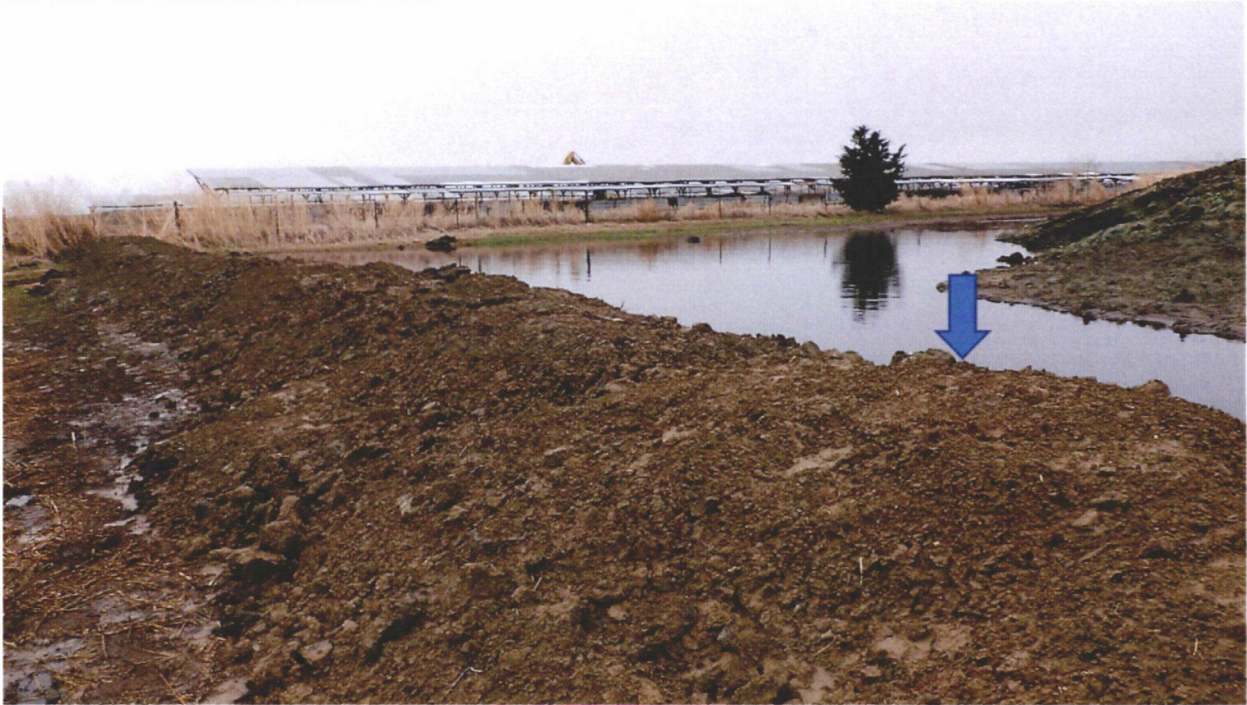
Photo: 5

Description: This photo depicts the berm containment around the east wet cake pile.
