Site Visit Report

Date Taken: 3-17-2021

Facility Name/ Project Name: AltEn LLC

Facility IIS number / Project identifier: IIS: 84069 / NE0137634

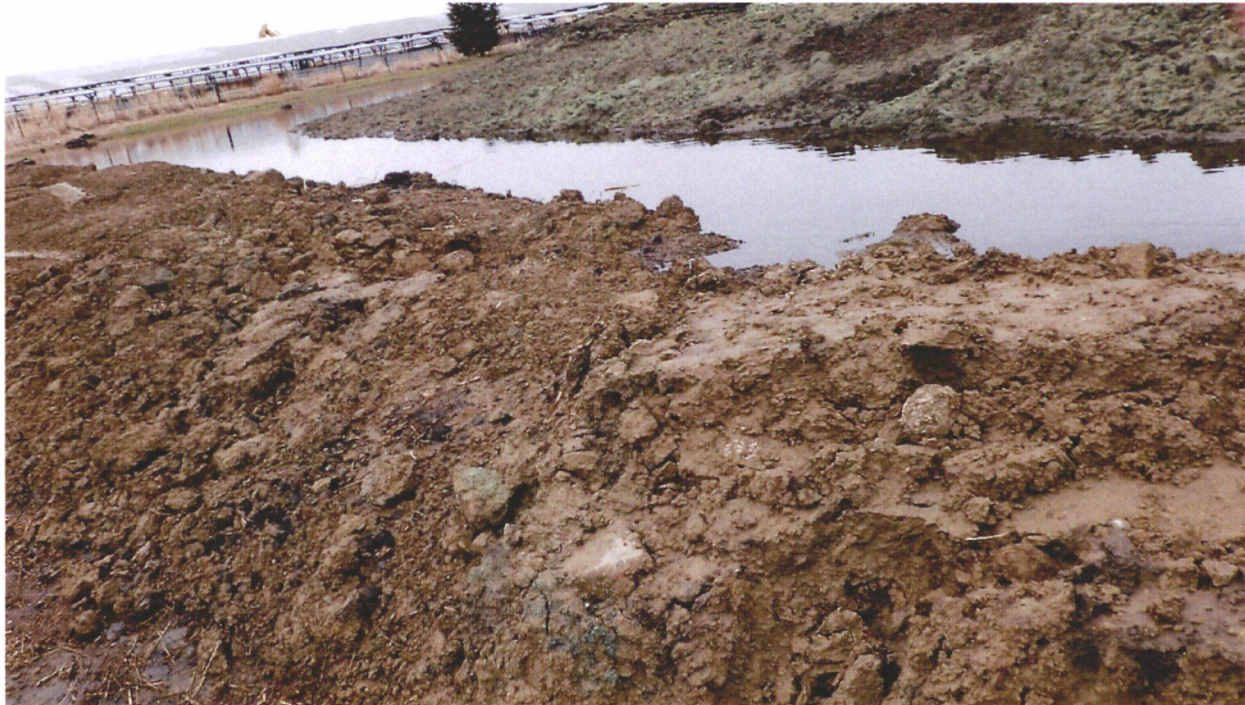
Photo: 6

Location: East wet cake pile

Description: This photo depicts the berm containment around the east wet cake pile. The berm is not breaching at this time but is at capacity. I instructed Mr. Peterson to maintain this area by adding dirt and pumping.

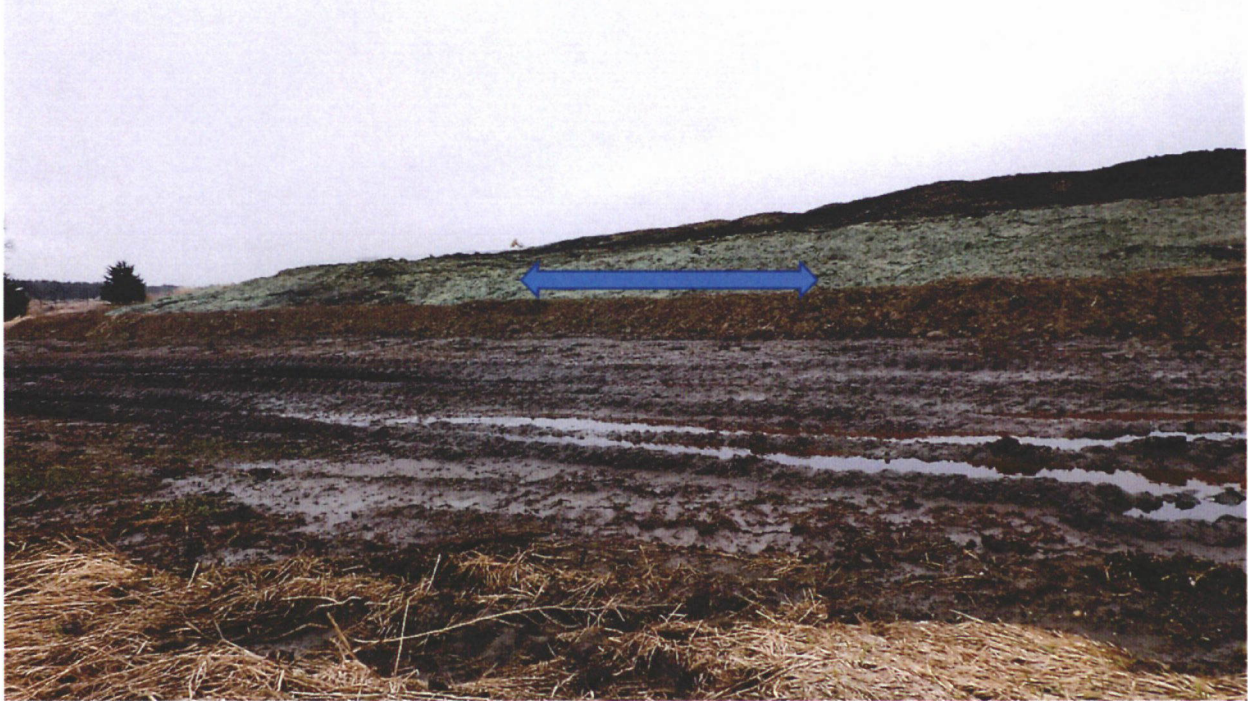
Photo: 7

Location: East wet cake pile

Description: This photo depicts the berm containment around the east wet cake pile (arrow). The photo depicts the berm from the west side of the water way.

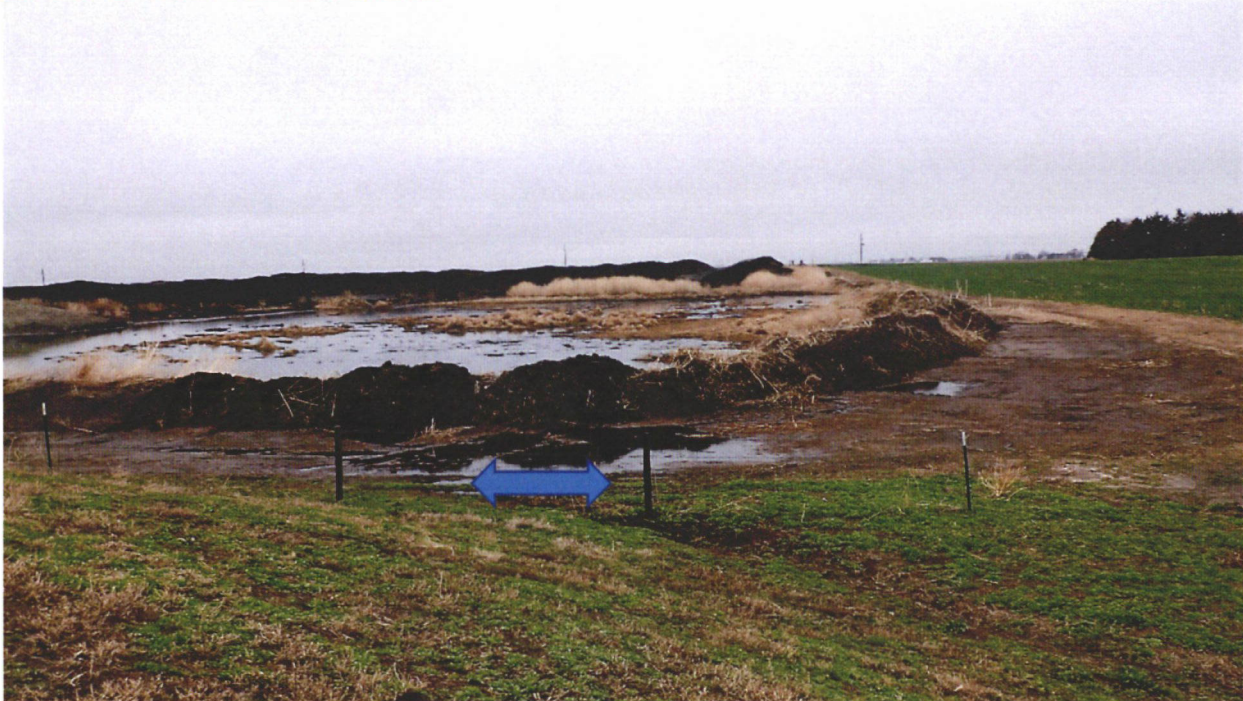
Photo: 7

Location: North wet cake pile

Description: This photo depicts the northwest corner of the northwest lagoon. There is accumulated water inside the berm. There is also some rainwater accumulation behind the berm (arrow). There is no evidence of leaking at this time.

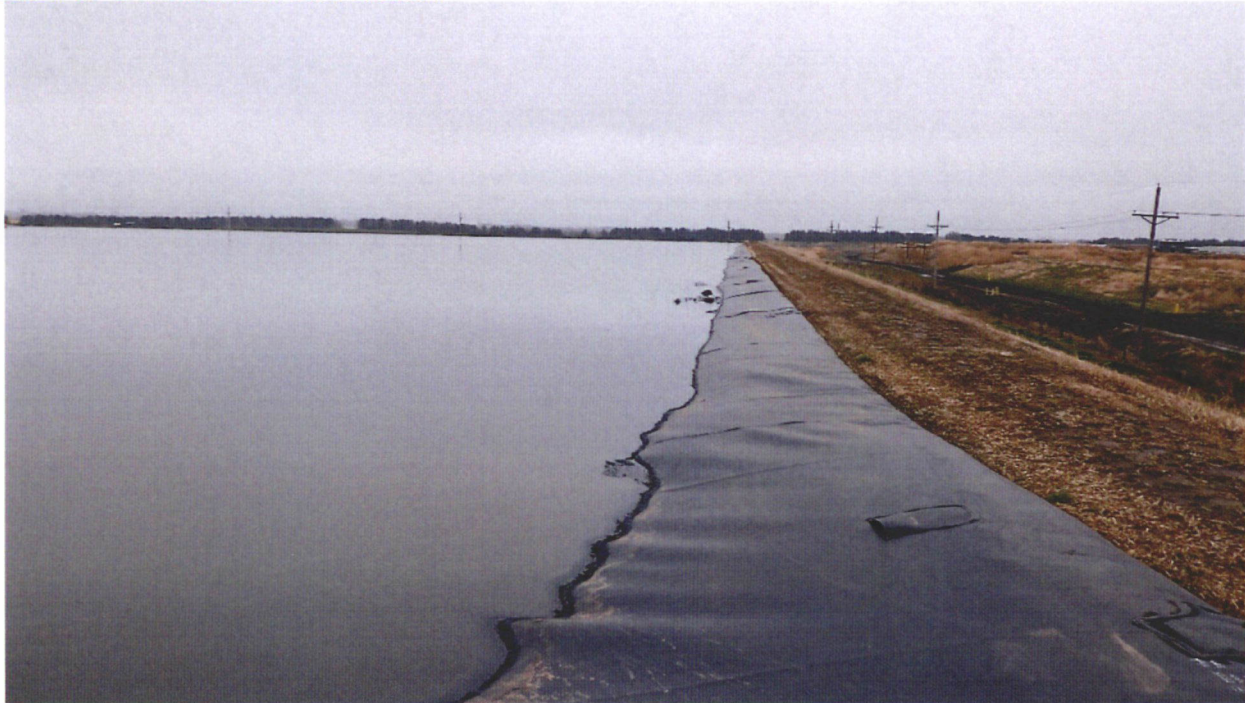
Photo: 8

Location: South lagoon

Description: This photo depicts the south lagoon. The lagoon appears lower than it did on Monday March 15, 2021.

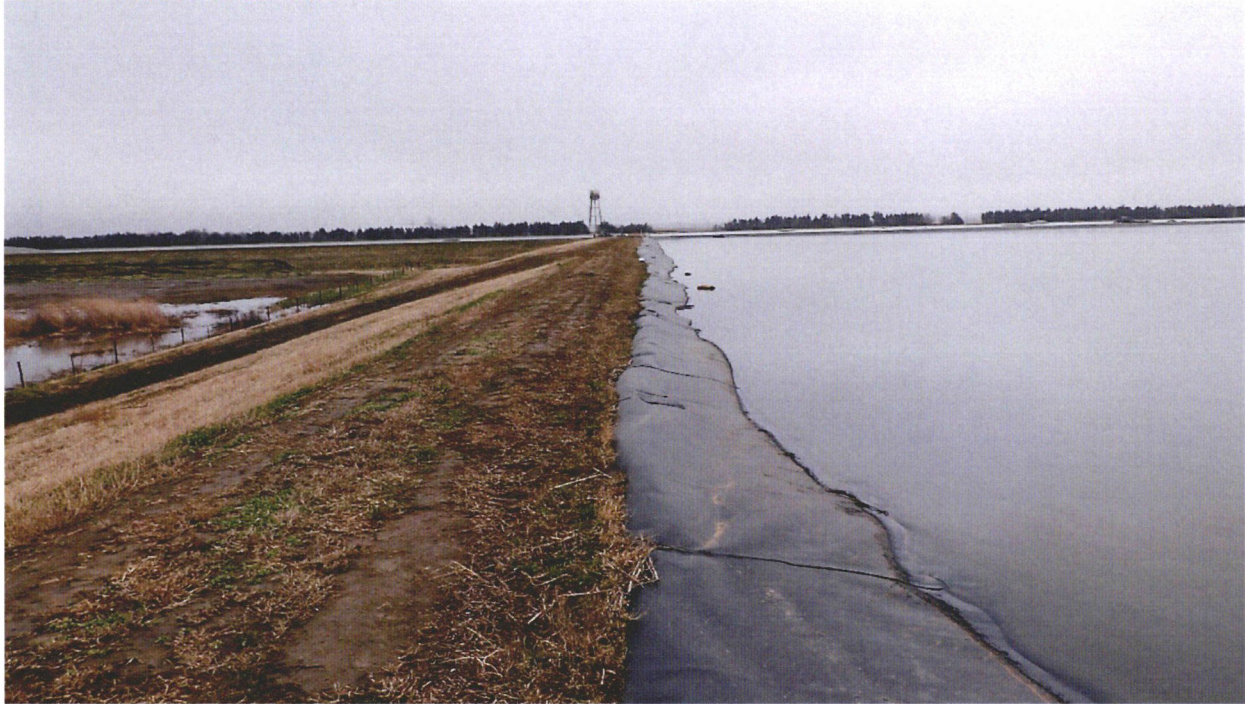
Photo: 9

Location: South lagoon

Description: This photo depicts the south lagoon.
