Photo: 10 Site Visit Report

Facility Name/ Project Name: AltEn LLC

Facility IIS number / Project identifier: IIS: 84069 / NE0137634

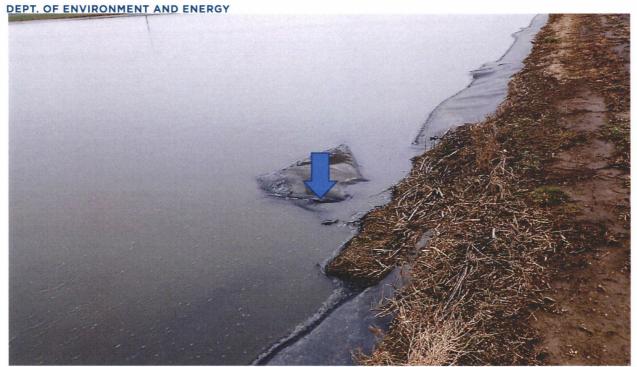
Location: South lagoon Direction Facing: North

Description: This photo depicts a possible tear in the south lagoon liner (arrow). This is located along the

south lagoon dike.

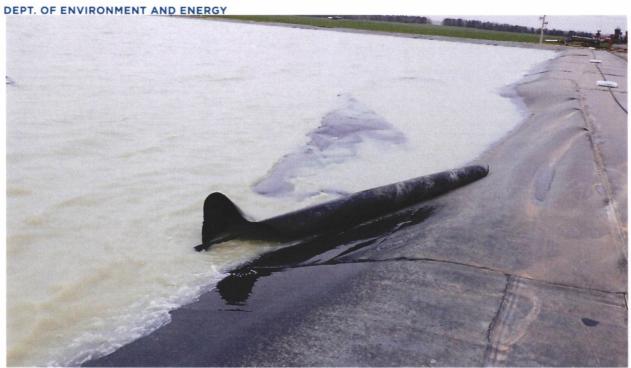
Photo: 11 Site Visit Report Date Taken: 3-17-2021 Photographer: Mark Pomajzl

Location: Northeast lagoon Direction Facing: East

Description: This photo depicts a torn liner floating against the south dike.

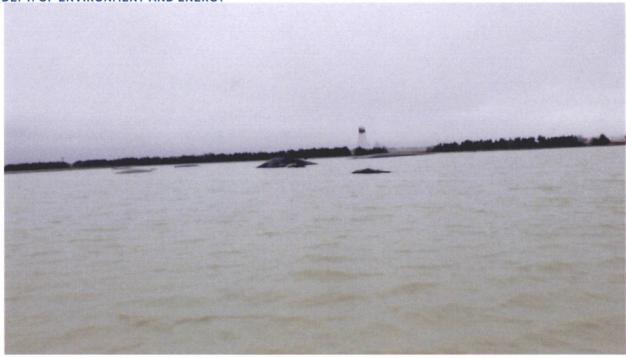
Photo: 12 Site Visit Report

Location: Northeast lagoon Direction Facing: North

Description: This photo depicts multiple whales in the northeast lagoon. The whales appear to be slightly

smaller today.
