Site Visit Report

Facility Name/ Project Name: AltEn LLC

Facility IIS number / Project identifier: IIS: 84069 / NE0137634

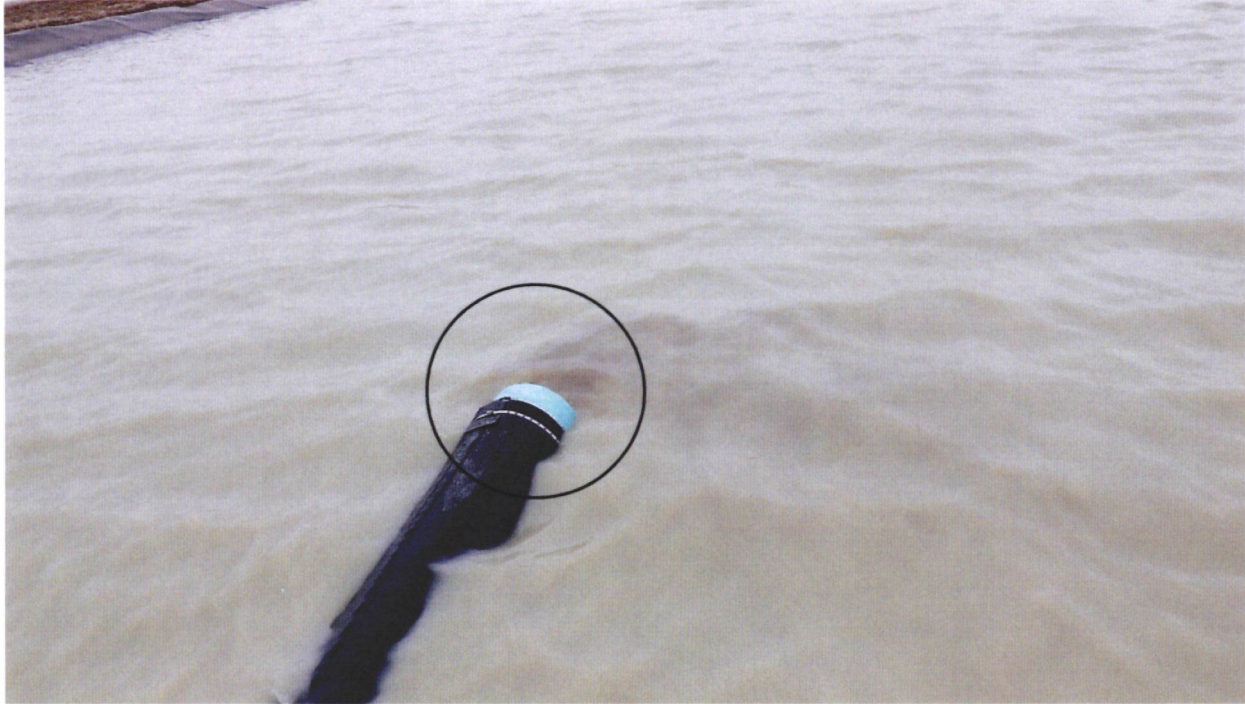
Photo: 13

Description: This photo depicts the equalization tube between the South and the Northeast lagoon. It appears that the south lagoon is flowing into the northeast lagoon. Notice the difference in color (circle).

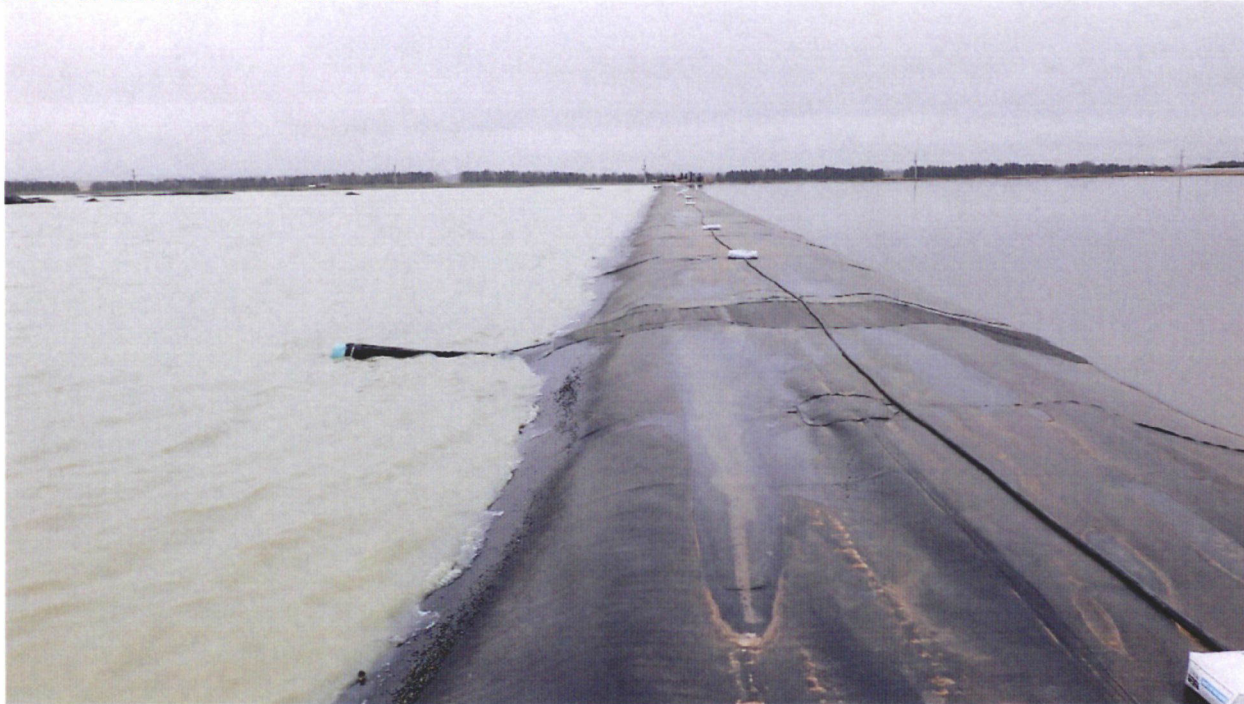
Photo: 14

Description: This photo depicts the dikes between the northeast and south lagoon. The photo also depicts the equalization tube between the two lagoons. There is lots of wave action in the northeast lagoon while the south lagoon is smooth.

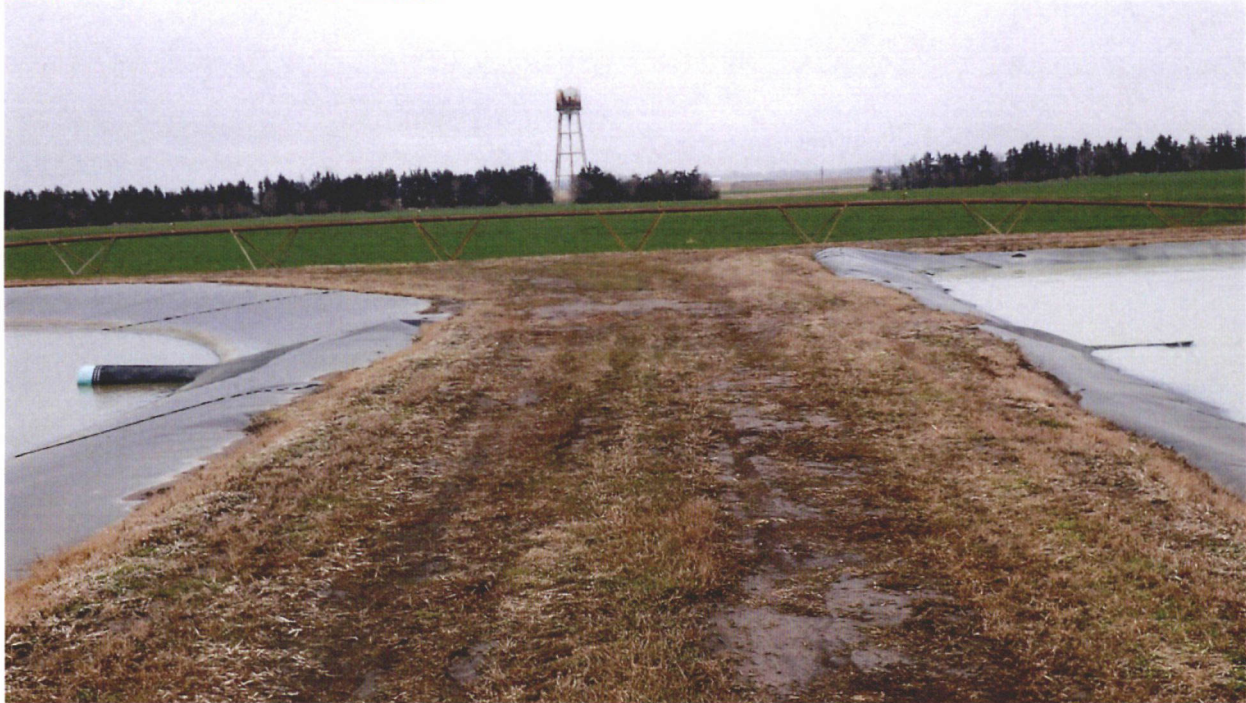
Photo: 15

Description: This photo depicts between the northeast and northwest lagoon. The photo also depicts the equalization tube..
