Site Visit Report

Facility Name/ Project Name: AltEn LLC

Facility IIS number / Project identifier: IIS: 84069 / NE0137634

Inspection and Assistance Exit Summary

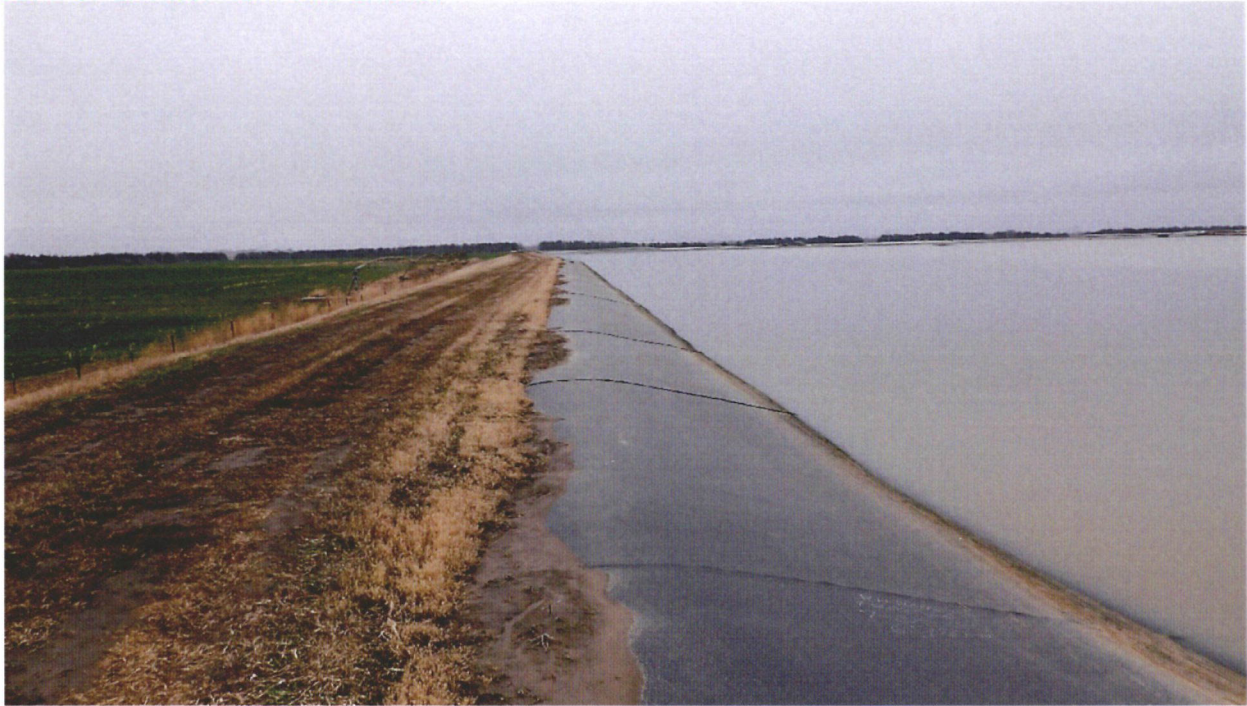
Photo: 17

Location: North side of the northwest lagoon

Description: This photo depicts the lagoon liner and freeboard.

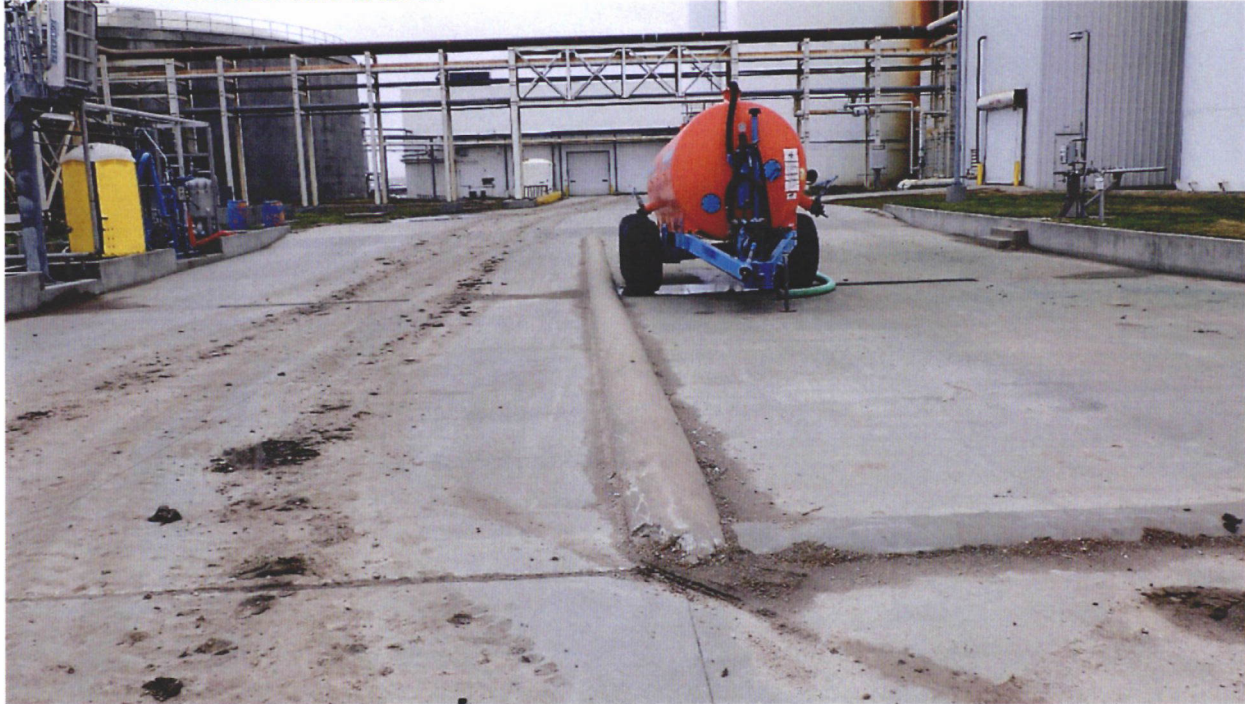
Photo: 18

Location: Ethanol loadout

Description: This photo depicts the honey wagon used to transfer water from the storm water containments.

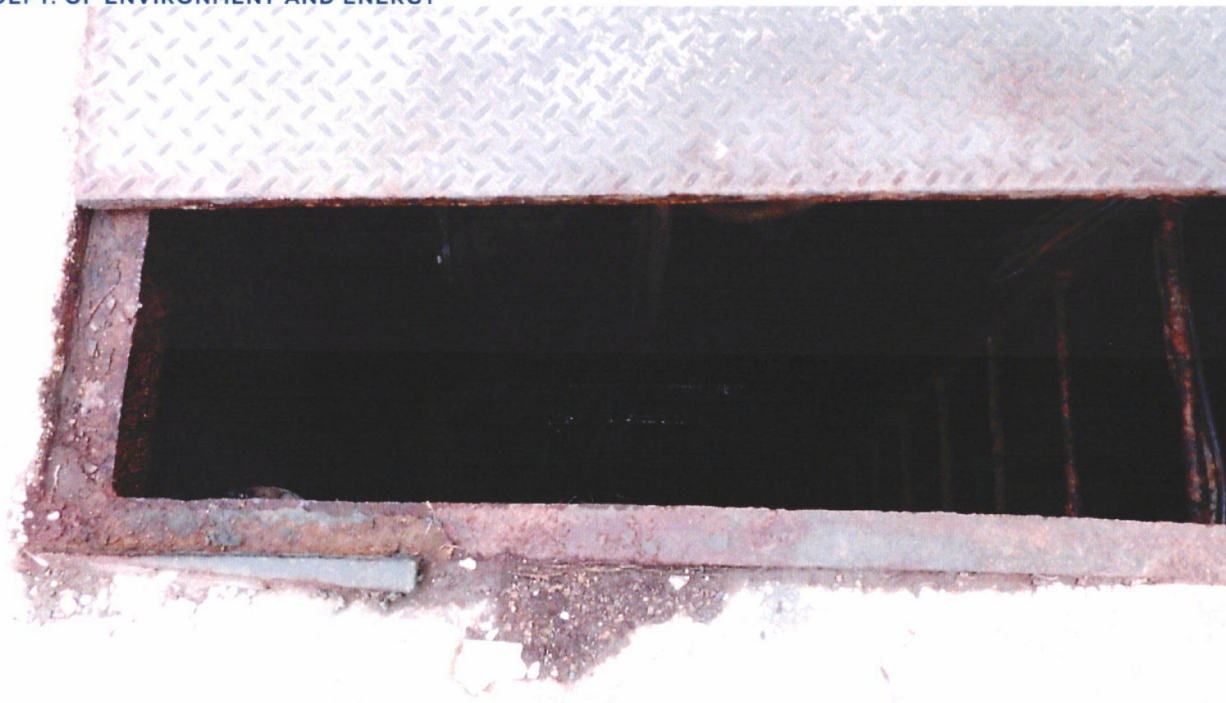
Photo: 19

Location: Lift station

Description: This photo depicts the lift station. There is very little water in the transfer box at this time. Mr. Peterson stated that storm water is conveyed through this station. Mr. Peterson also stated that one to two thousand gallons of solids from the new treatment system enters this lift station. The lift station pumps directly to the lagoon system.

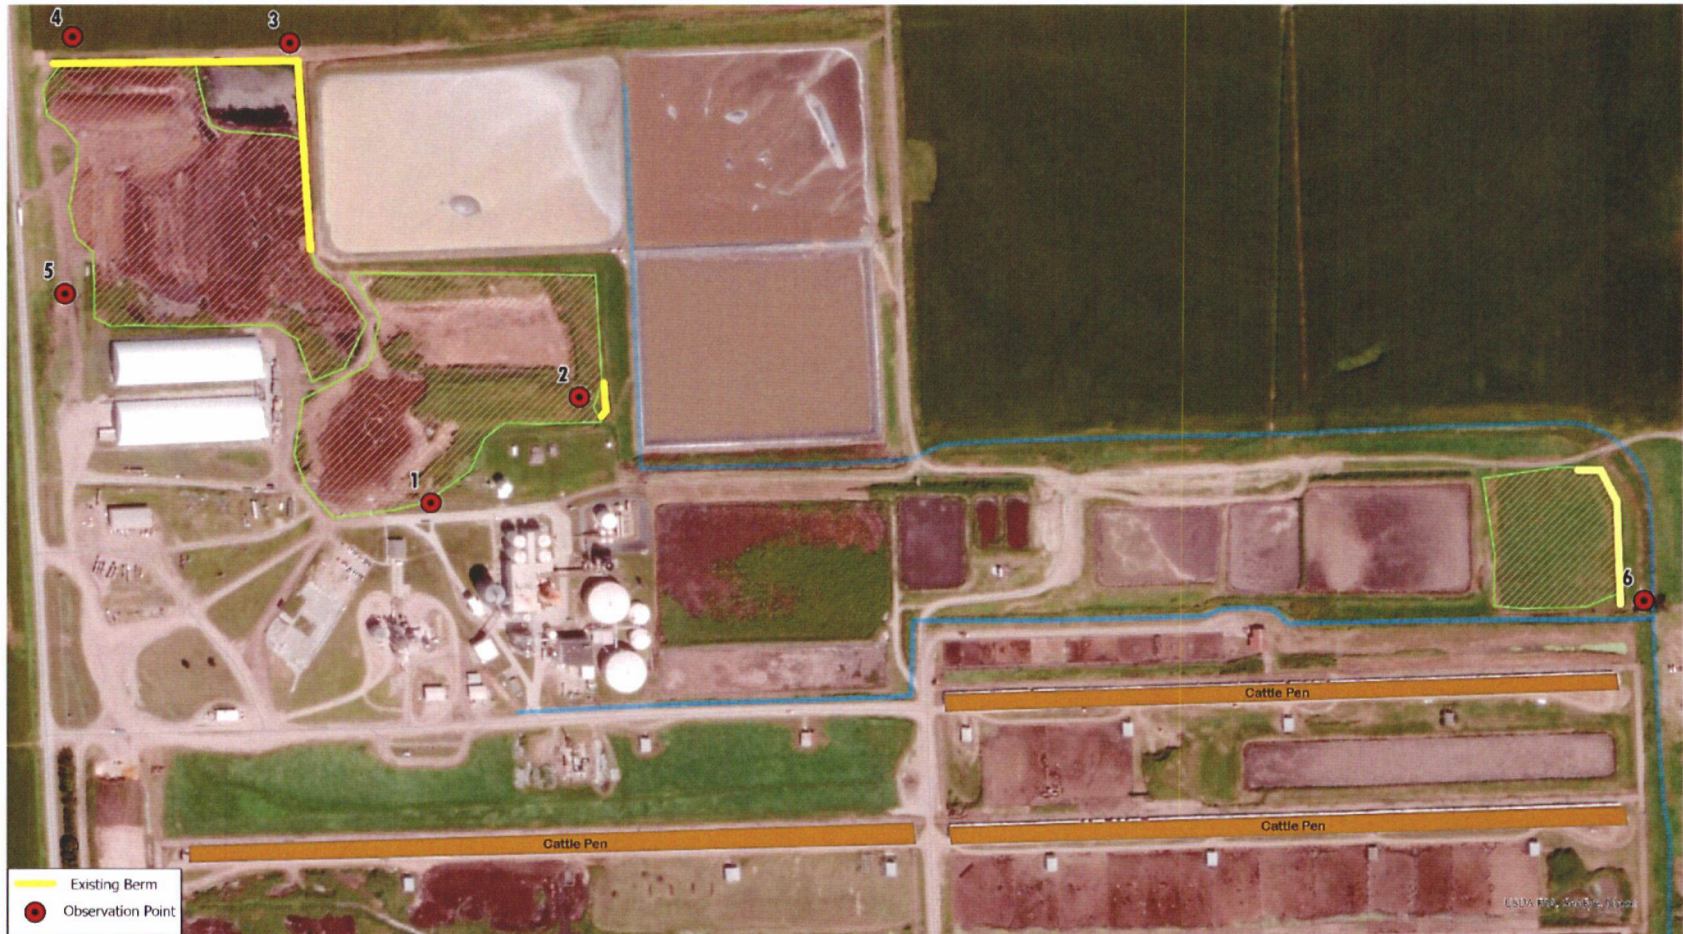
AltEn LLC - Storm Water Temporary BMP Check Map

- * Northside of main office Building Beem - OK
- * Southwest side of South Lagoon (Beem) - OK
- * West side of Northwest Lagoon - OK
- * West side of Northwest pile - OK
- * EAST side wet cake pile - OK. However appears to be a weak area @ North of the fence.

- monitor the beams - and provide email.
- monitor the dikes on the Lagoons & keep us informed & act accordingly of any possible overflows or breaches.
