Hartford Comparative Leak Reports

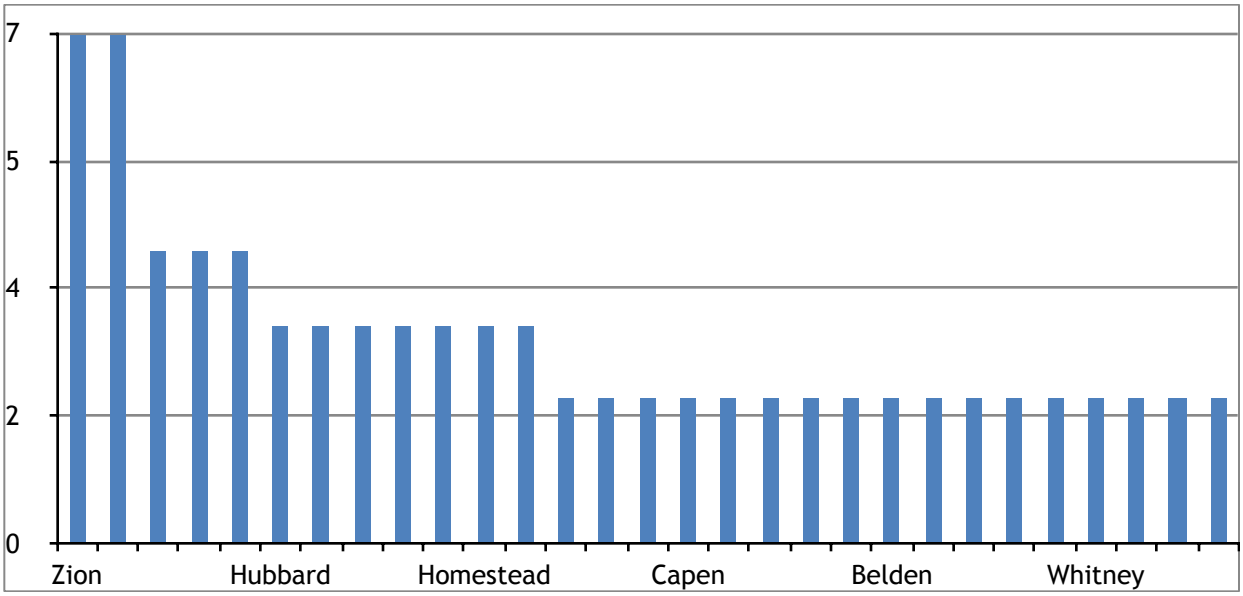
Figure 1. Reports To PURA– October 15, 2015 to October 17, 2016. Graph showing 7-2 highlighted is yellow. Totals are: 2 streets x 7 leaks; 3 (st.) x 4 (lk); 7 (st.) x 3 (lk); 17 x 2; 58 x 1 per street. TOTAL 139.

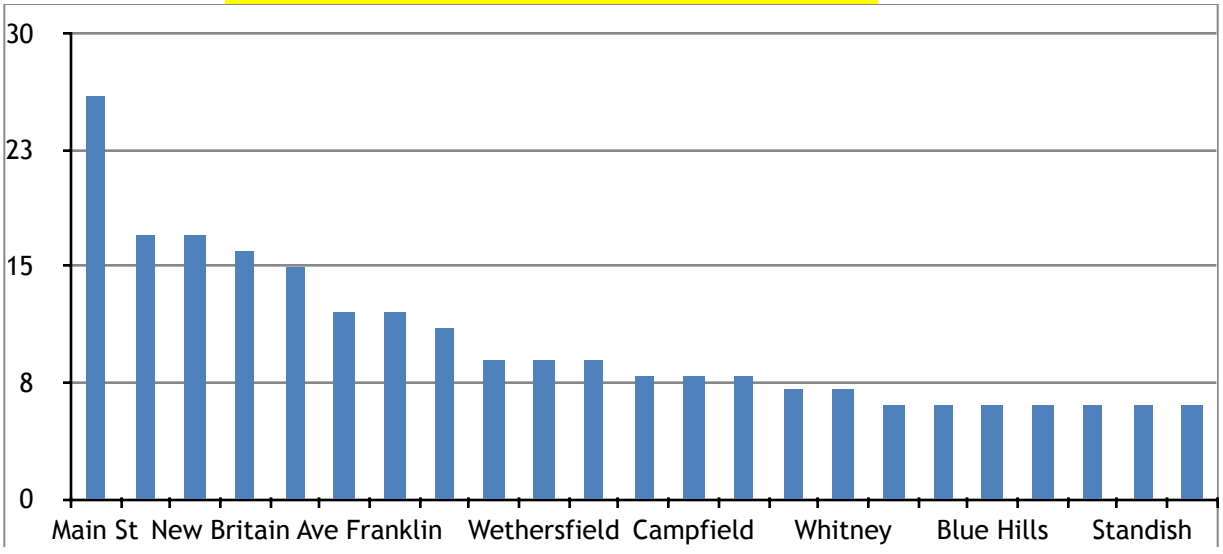
Figure 2. Tests by Gas Safety Inc. - February 25, 2016 to March 31, 2016. Graph showing 26 – 6 highlighted in yellow. Totals are: 1 streets x 26 leaks; 2 streets x 17 leaks; 1 x 16; 1 x 15; 2 x 12; 1 x 11; 3 x 9; 3 x 8; 2 x 7; 7 x 6; 14 x 5; 21 x 4; 33 x 3; 2 x 48; 1 x 122 per street. TOTAL 704.
