Industrial Storm Water Pollution in Wolf River Harbor

April 2003

Water Sentinels Campaign
April 2003

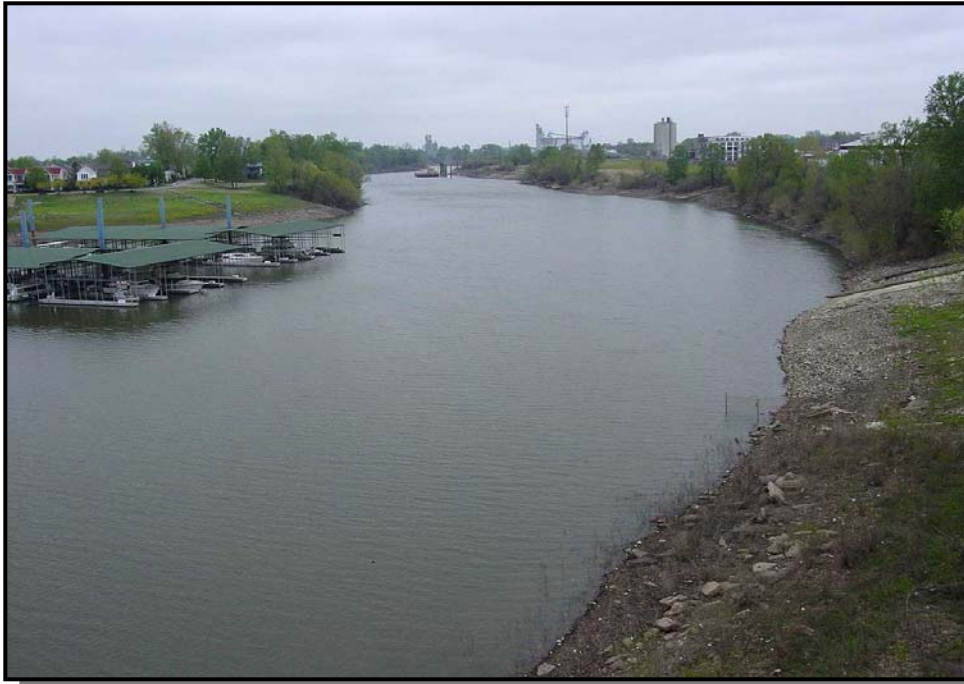
Top Photo: *Wolf River Harbor is a slack water harbor that receives its recharge from the influx of the Mississippi River at its open southern terminus and from storm water discharges from its four square mile watershed.*

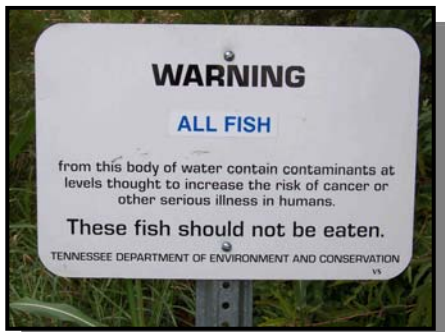
Bottom Photo: *Warning sign at Wolf River Harbor.*
