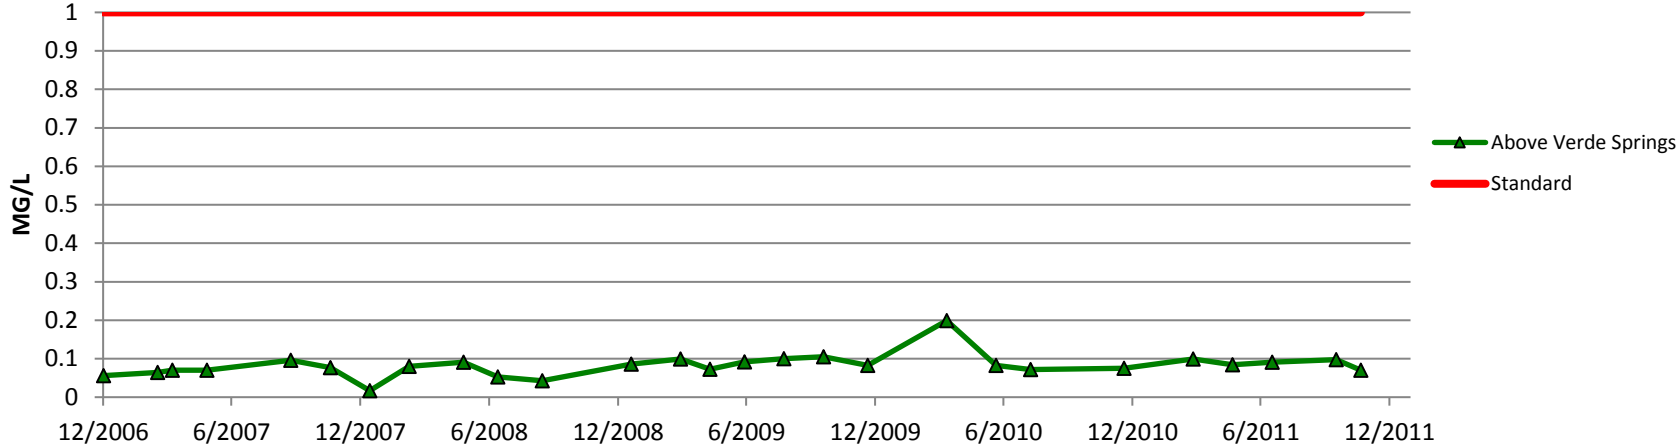
Above Verde Springs Total Phosphorus (Standard: 1.000)

Phosphorus measurements were taken from 2006-2011, then stopped as no exceedances had been observed. Monitoring at White Bridge ceased in 2010, and a new site at Black Bridge was added at that time.

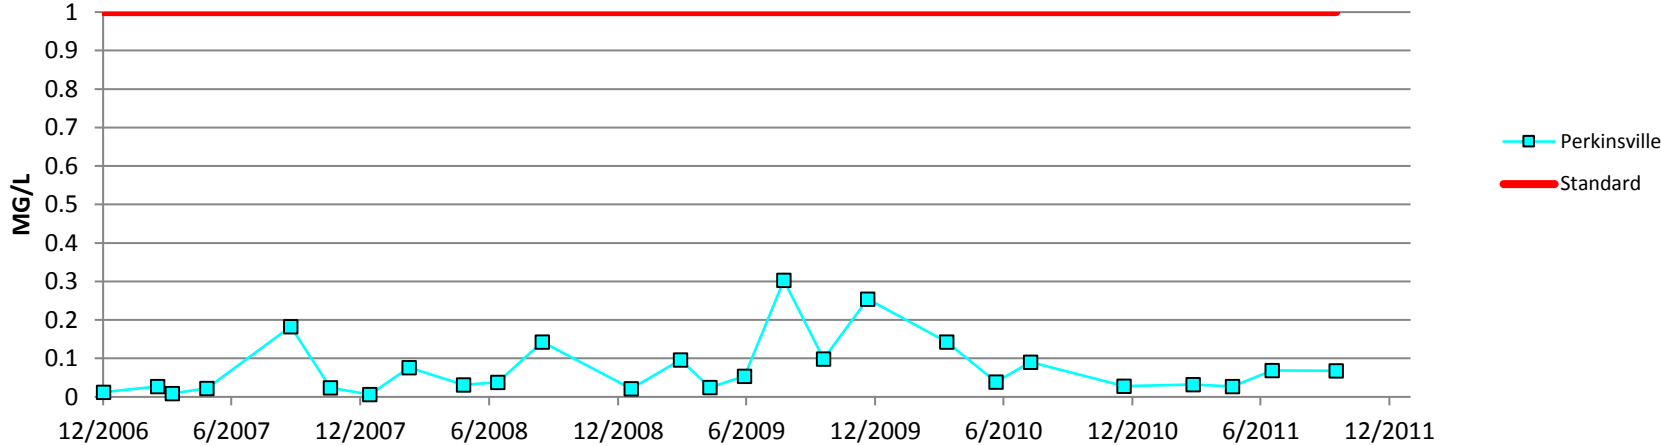
Perkinsville Total Phosphorus (Standard: 1.000)

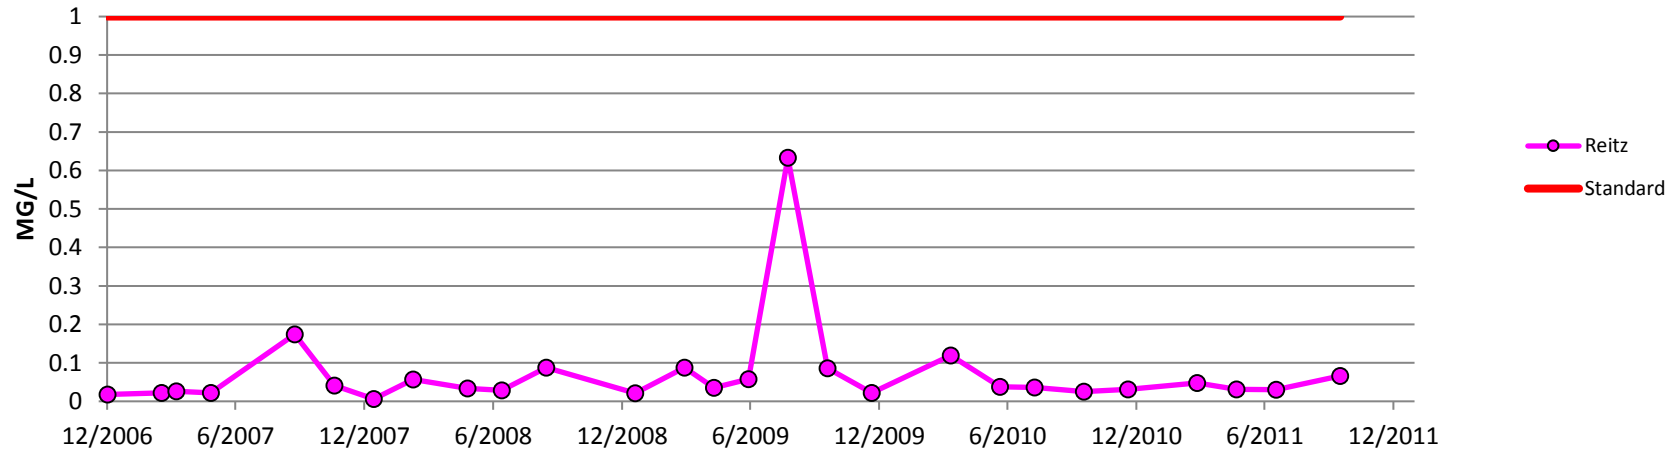
Reitz Total Phosphorus (Standard: 1.000)

Phosphorus measurements were taken from 2006-2011, then stopped as no exceedances had been observed. Monitoring at White Bridge ceased in 2010, and a new site at Black Bridge was added at that time.

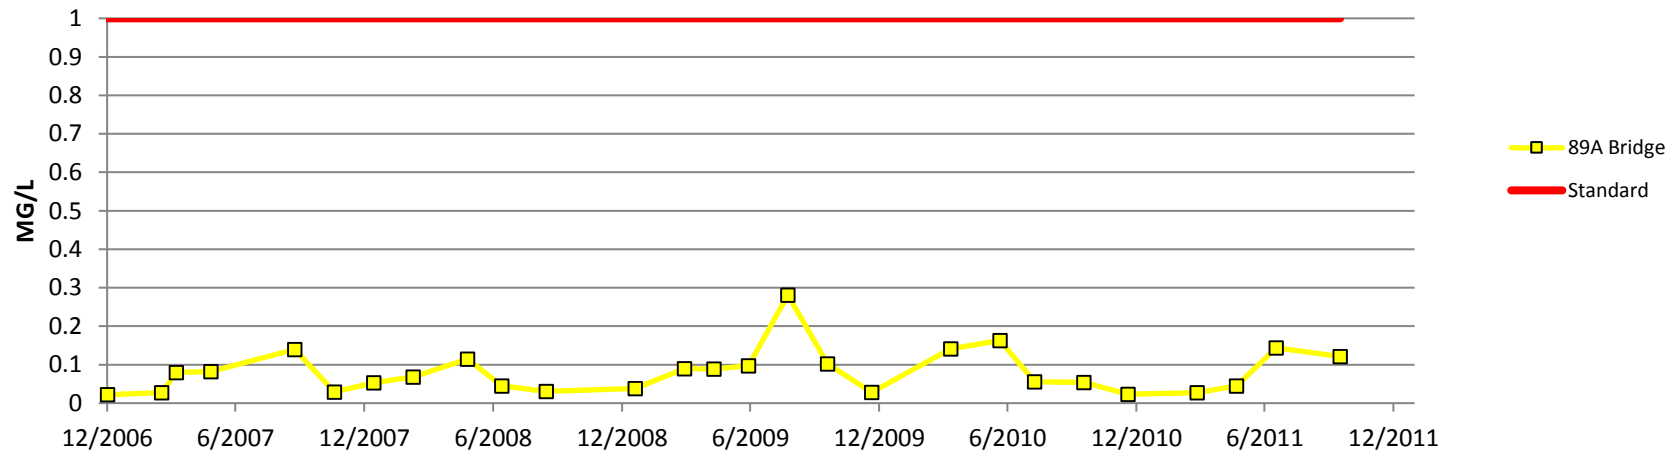
89A Bridge Total Phosphorus (Standard: 1.000)

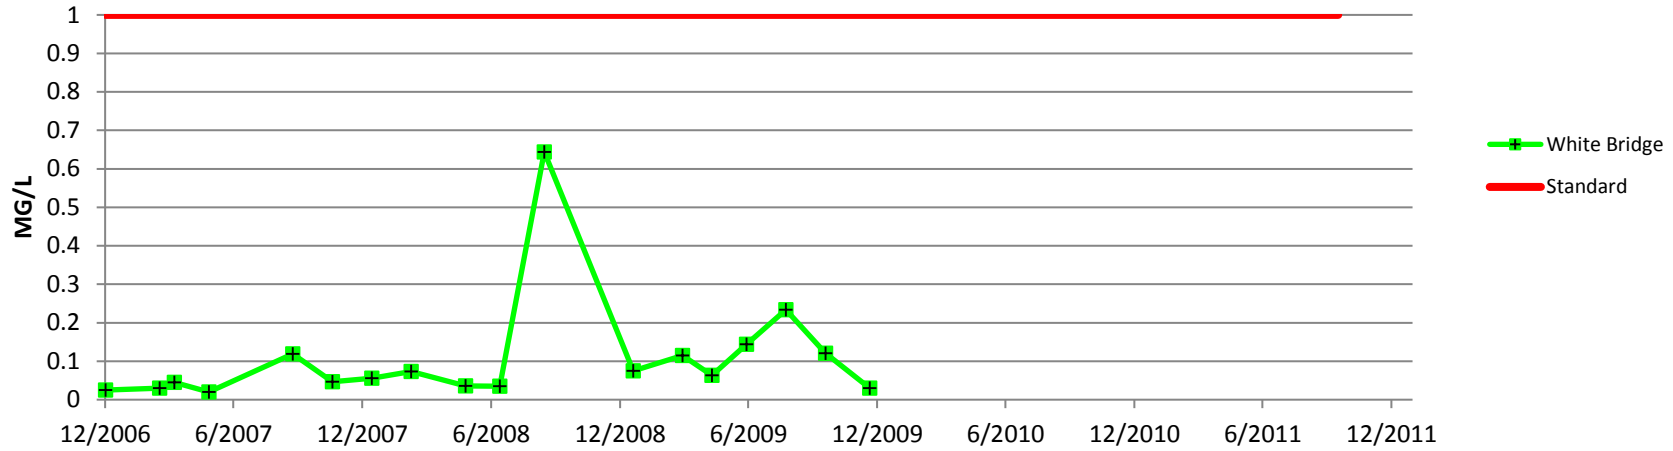
White Bridge Total Phosphorus

(Standard: 1.000)

Phosphorus measurements were taken from 2006-2011, then stopped as no exceedances had been observed. Monitoring at White Bridge ceased in 2010, and a new site at Black Bridge was added at that time.

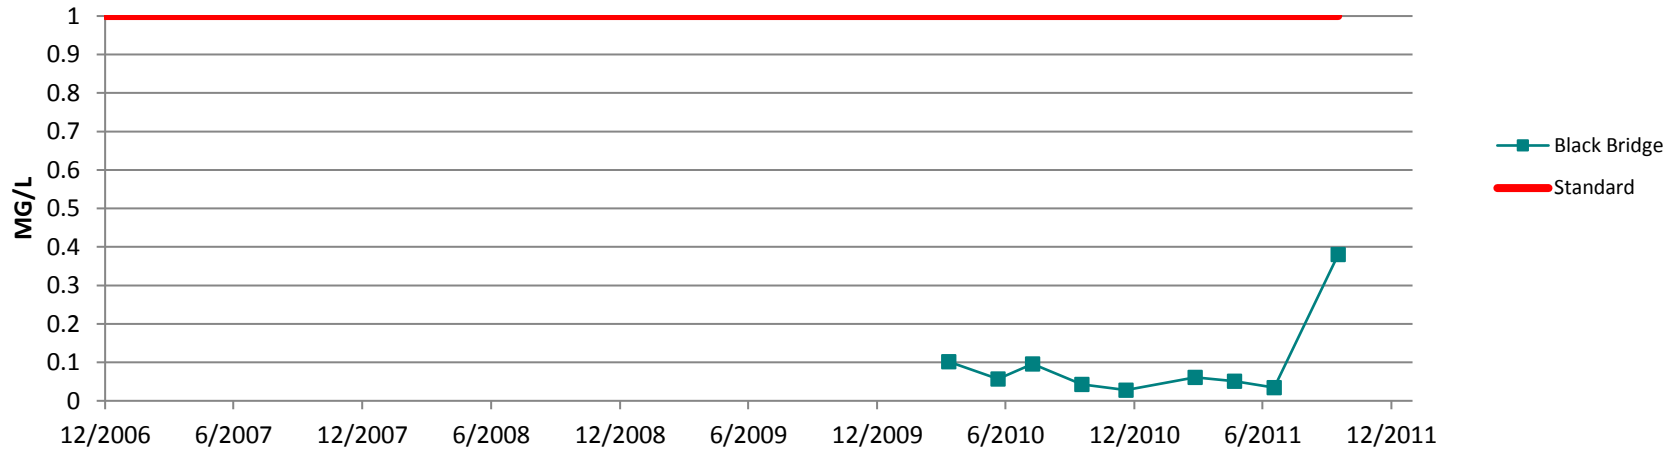
Black Bridge Total Phosphorus

(Standard: 1.000)

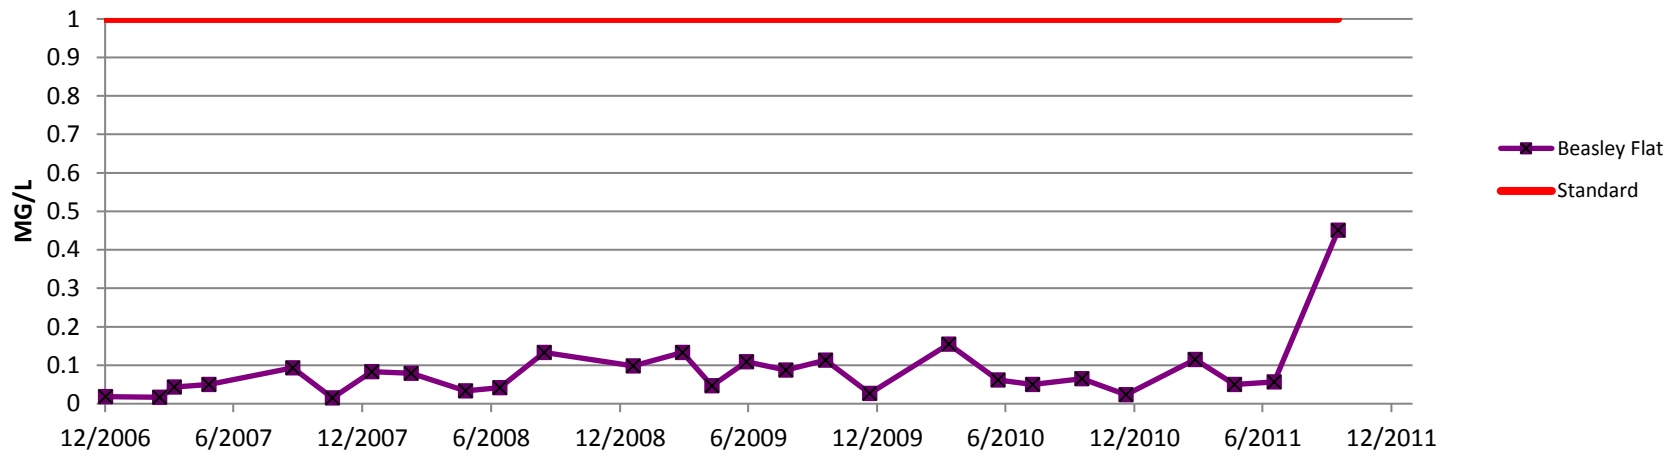
Beasley Flat Total Phosphorus (Standard: 1.000)

Phosphorus measurements were taken from 2006-2011, then stopped as no exceedances had been observed. Monitoring at White Bridge ceased in 2010, and a new site at Black Bridge was added at that time.
