DRG/WSSI Maryland Statewide Umbrella Mitigation Bank

Final Prospectus

June 17, 2021

**Lake Elkhorn Stream Restoration
Exhibit 11 – Existing Condition Photos
WSSI #7001.01**

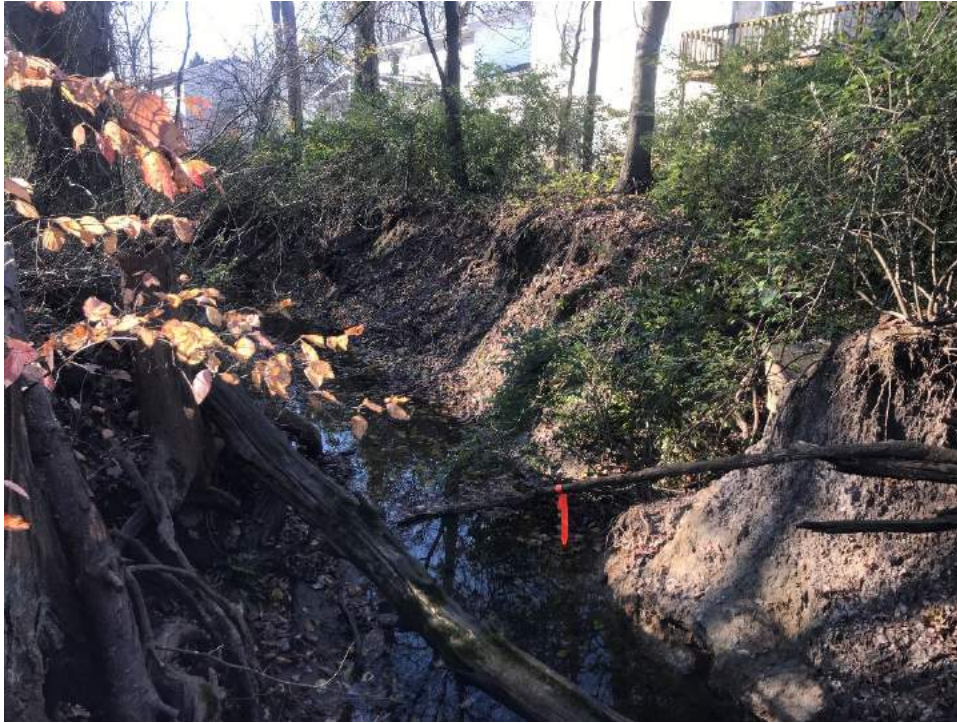
Photo 1: Reach 1A, looking downstream, 4' actively eroding stream bank.

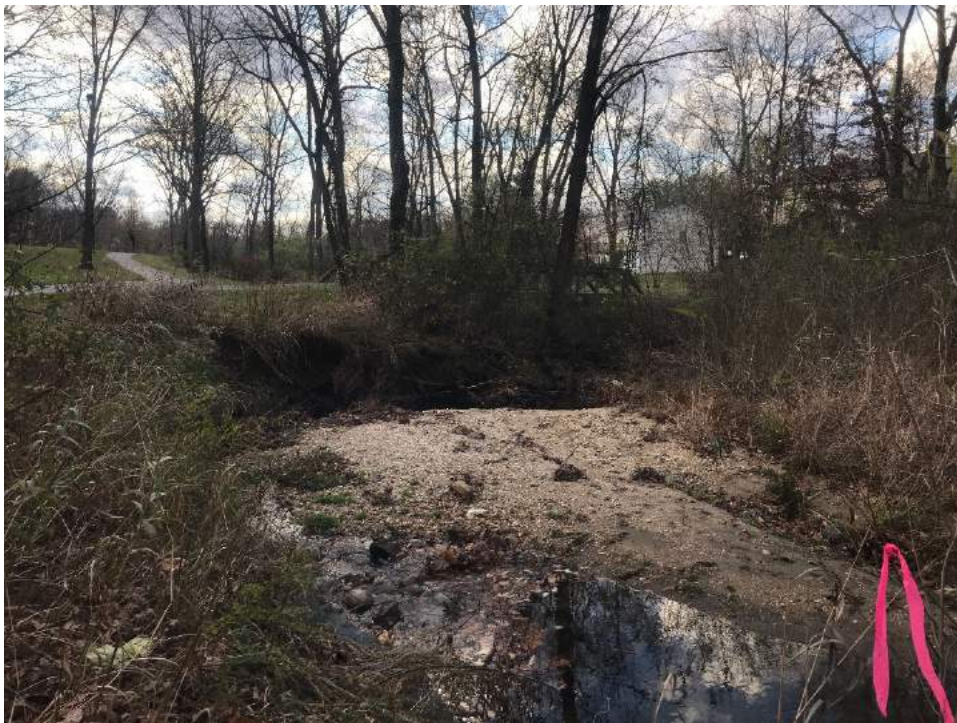
Photo 2: Reach 1B, looking downstream towards Jackson Pond, 3' actively eroding bank with minimal riparian vegetation.

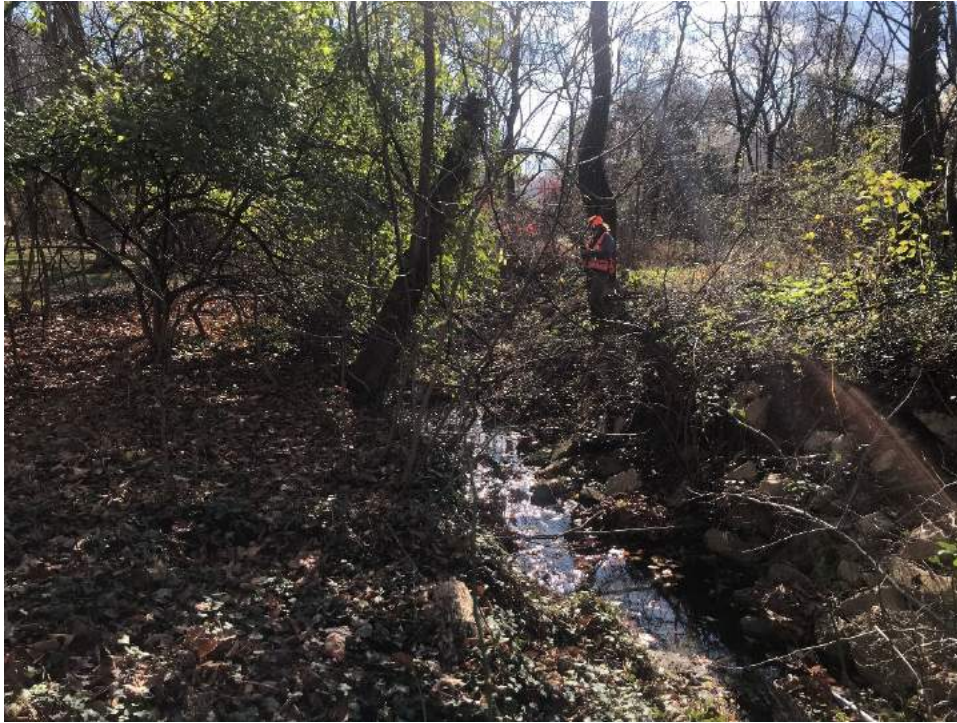
Photo 3: Reach 2, looking downstream near Blade Green Ln, 3' actively eroding stream banks. The riparian area contains a high concentration of invasive species.

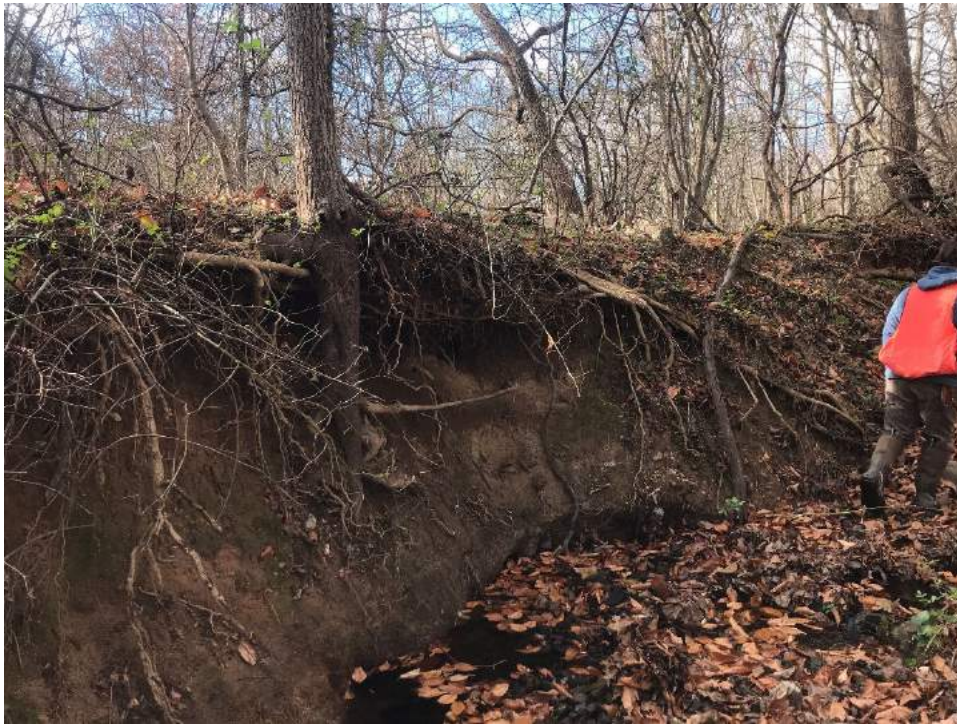
Photo 4: Reach 3-1, looking downstream towards Reach 3A, 4' actively eroding stream bank.

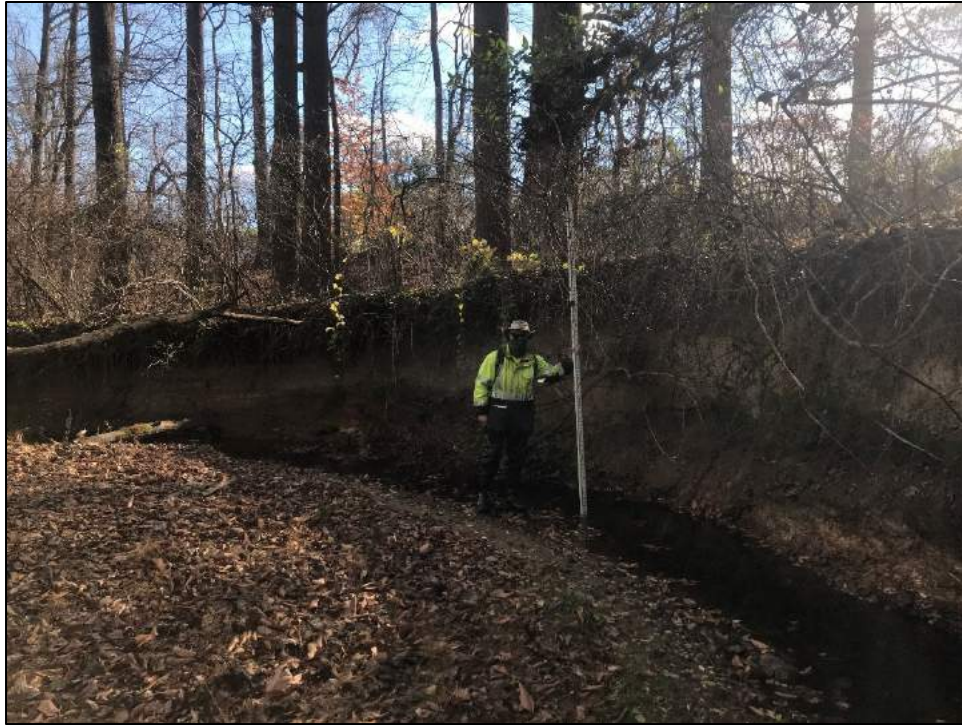
Photo 5: Reach 3A, looking downstream towards Lamb Skin Ln, 6' actively eroding bank.

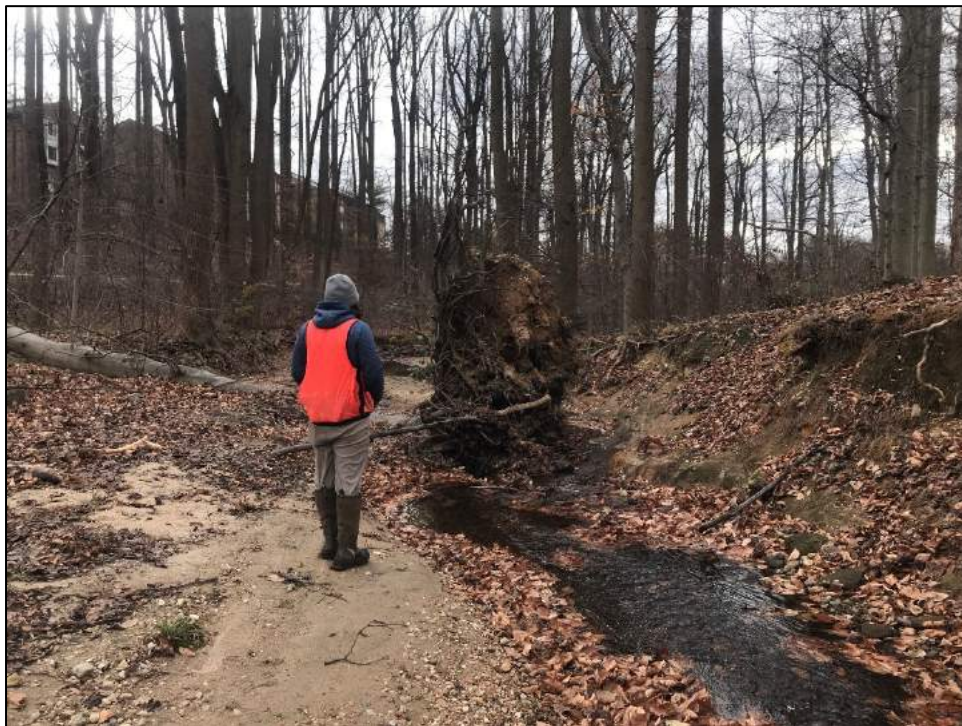
Photo 6: Reach 3B, looking downstream towards Lamb Skin Ln, 4' actively eroding bank with fallen tree.

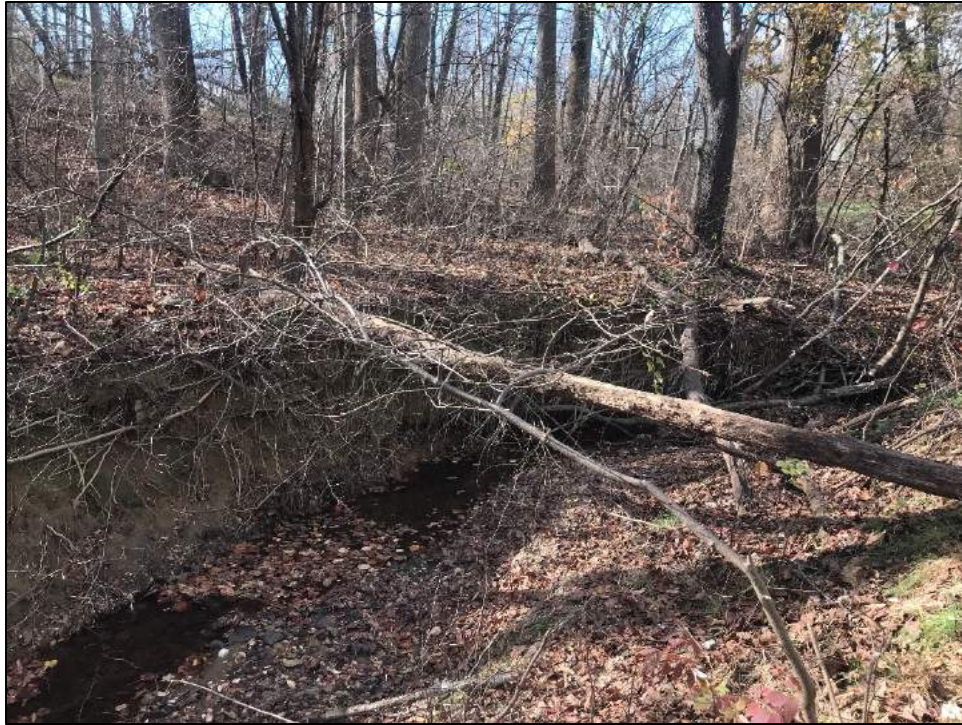
Photo 7: Reach 4, looking downstream towards Reach 3A, 3' actively eroding bank.

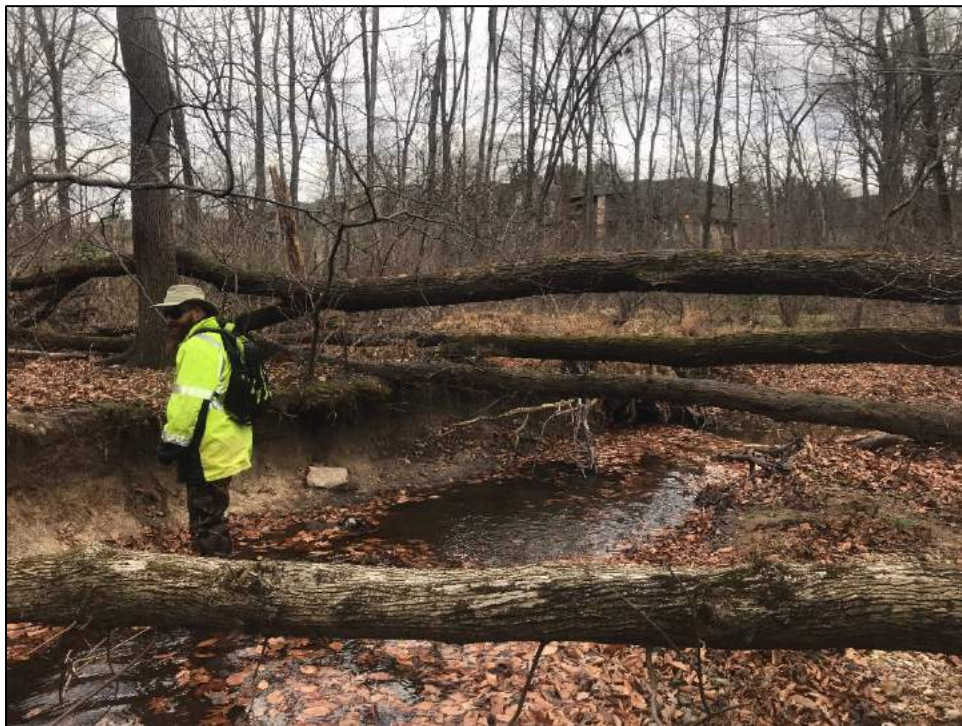
Photo 8: Reach 5, looking downstream towards Reach 3B, 3' actively eroding bank.

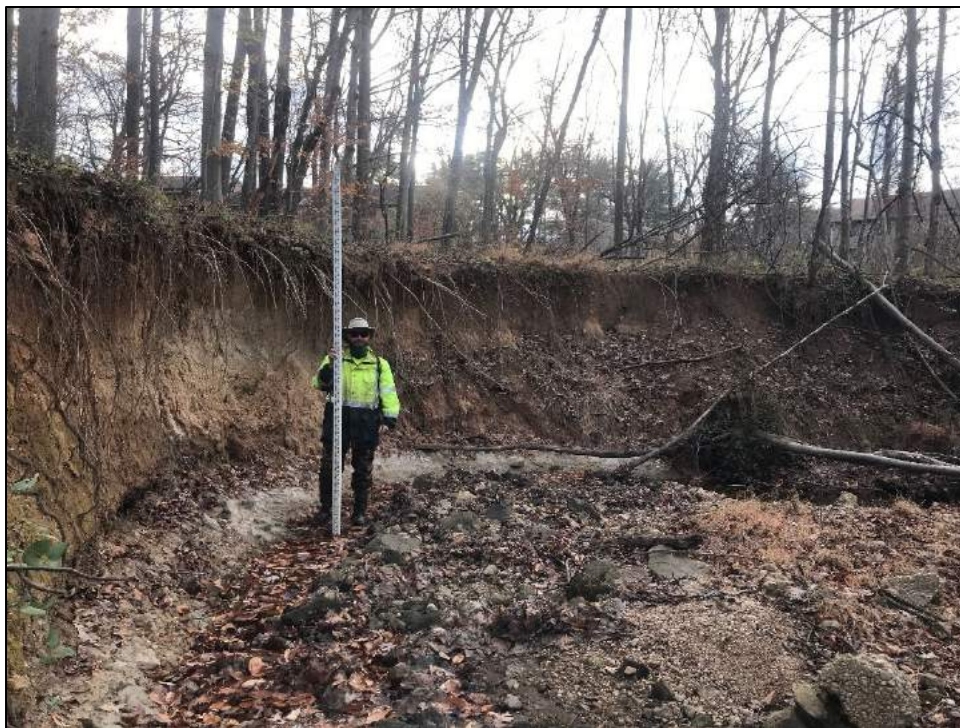
Photo 9: Reach 6, looking downstream near Tamar Drive, 9' eroding bank.

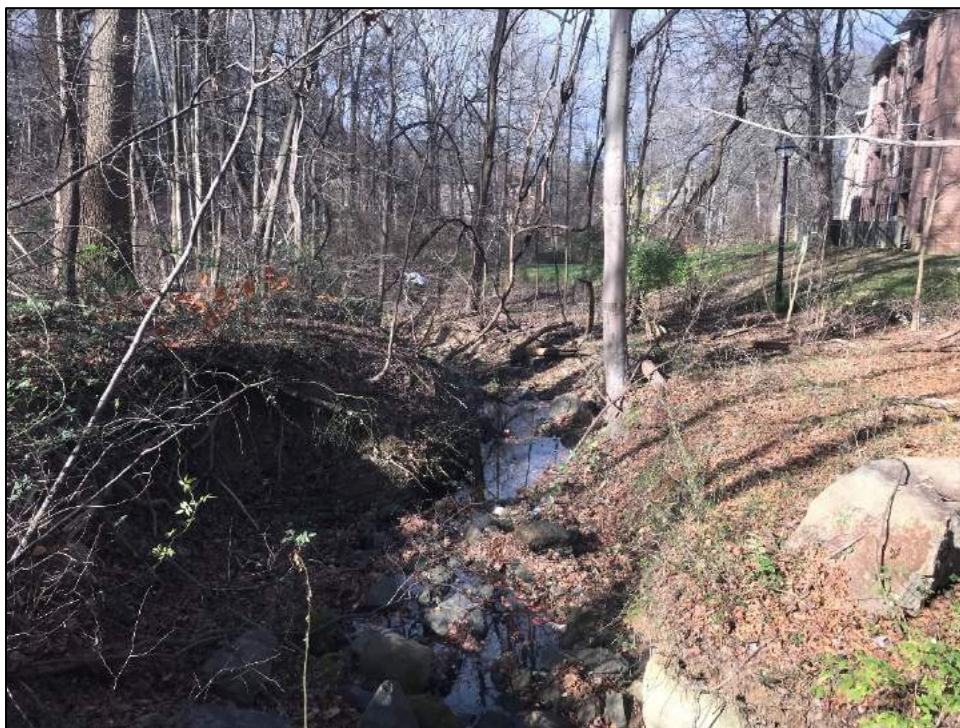
Photo 10: Reach 7, looking downstream near Cloudleap Ct, 3' actively eroding bank with minimal riparian vegetation.

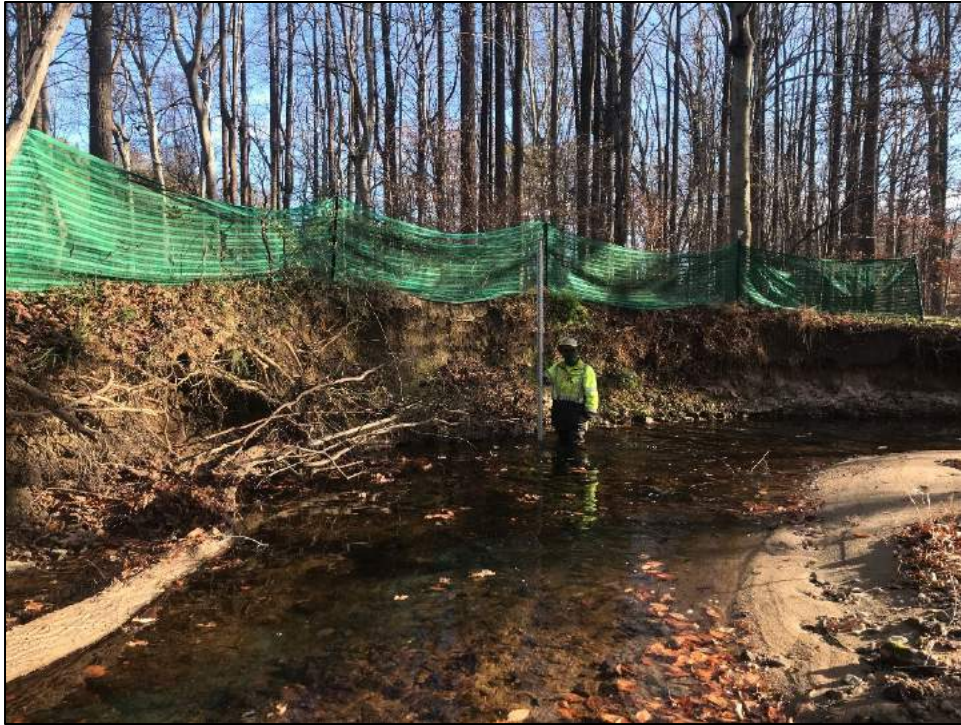
Photo 11: Reach 8A, looking downstream near Majors Ln, 8' actively eroding bank impacting nearby pedestrian path.

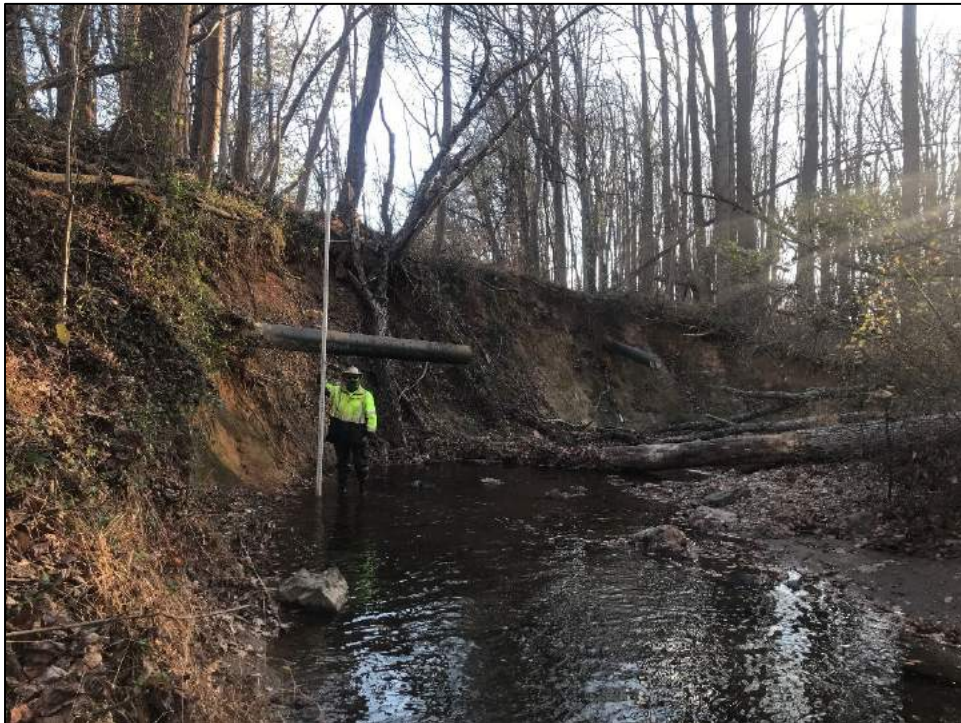
Photo 12: Reach 8B, looking downstream near Route 175, 12' actively eroding bank with disconnected and exposed pipes.

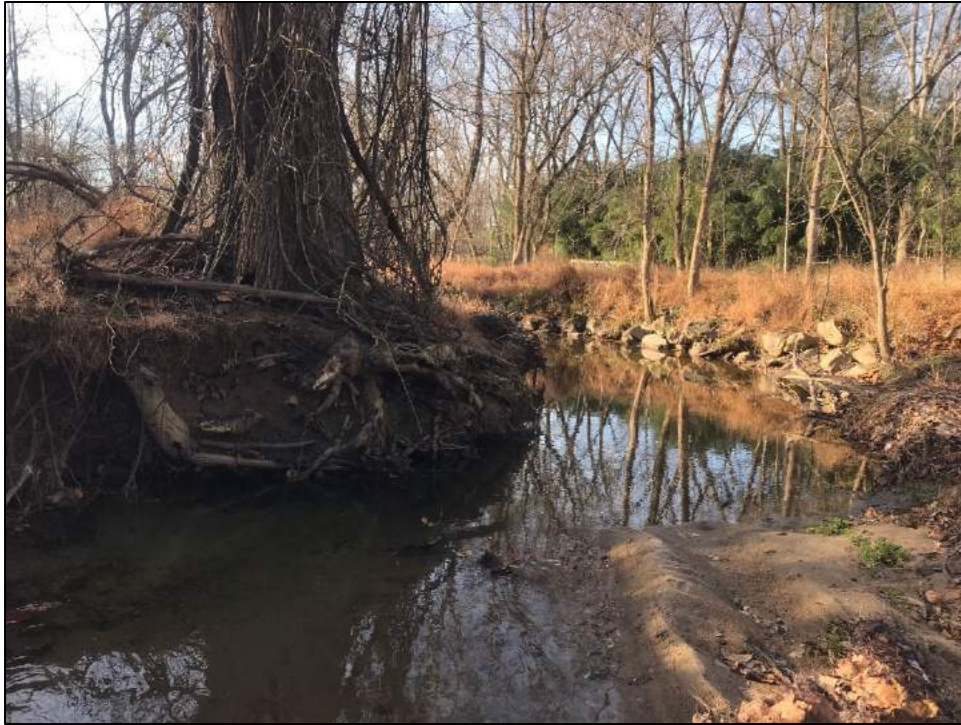
Photo 13: Reach 8D, looking downstream near confluence with Reach 14, 4' actively eroding bank undercutting large tree.

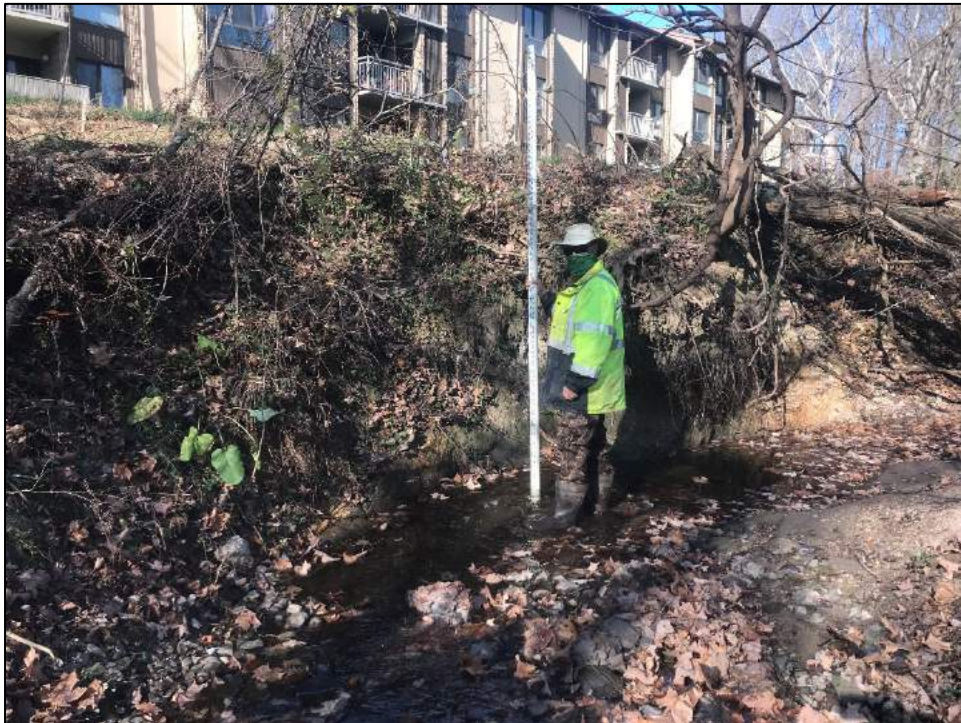
Photo 14: Reach 9A, looking downstream near Majors Ln, 7' actively eroding bank with minimal riparian vegetation.

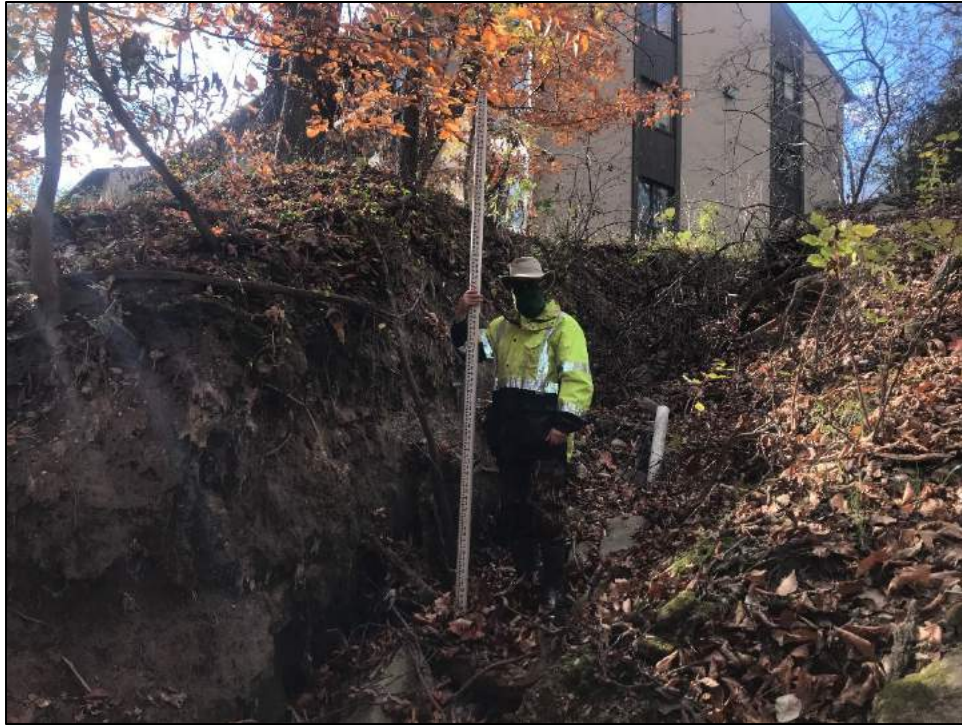
Photo 15: Reach 10, looking at side channel near the corner of Tamar Drive and Route 175, 7' eroding bank where apartment complex outfall meets Reach 10.

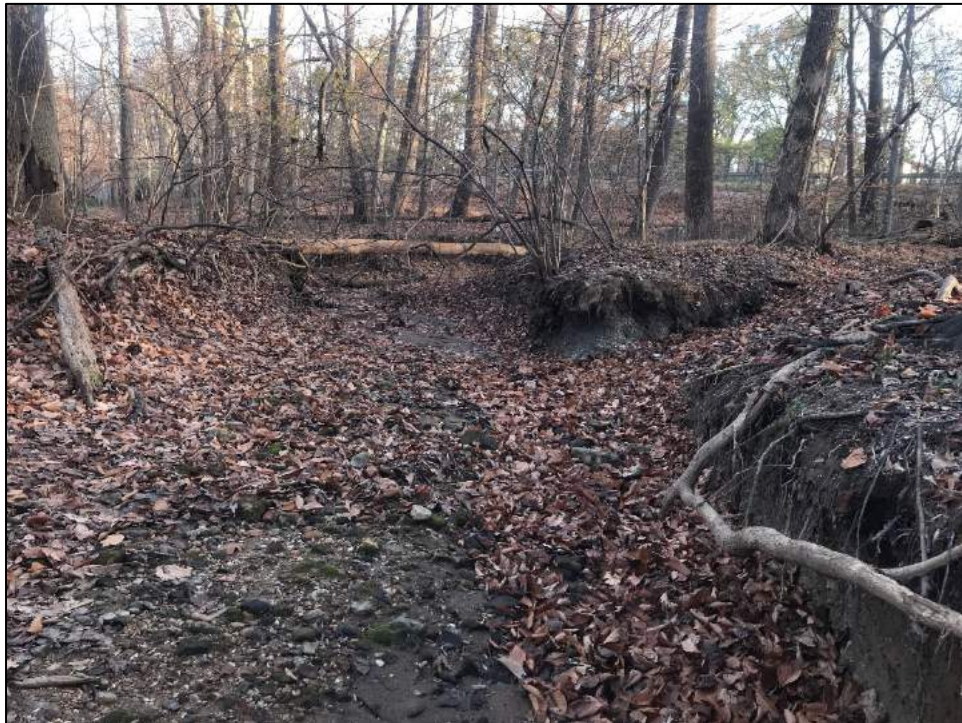
Photo 16: Reach 11, looking downstream near confluence with Reach 8A, 3' actively eroding bank with over widened channel.

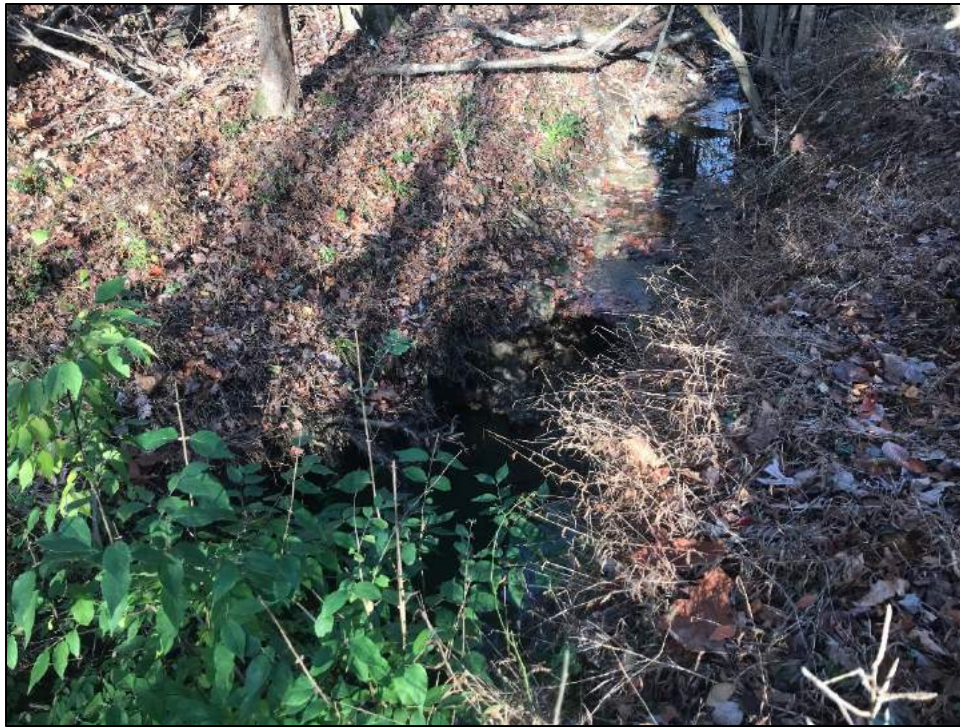
Photo 17: Reach 12, looking upstream near Stone Cloud Rd, 3' head cut.

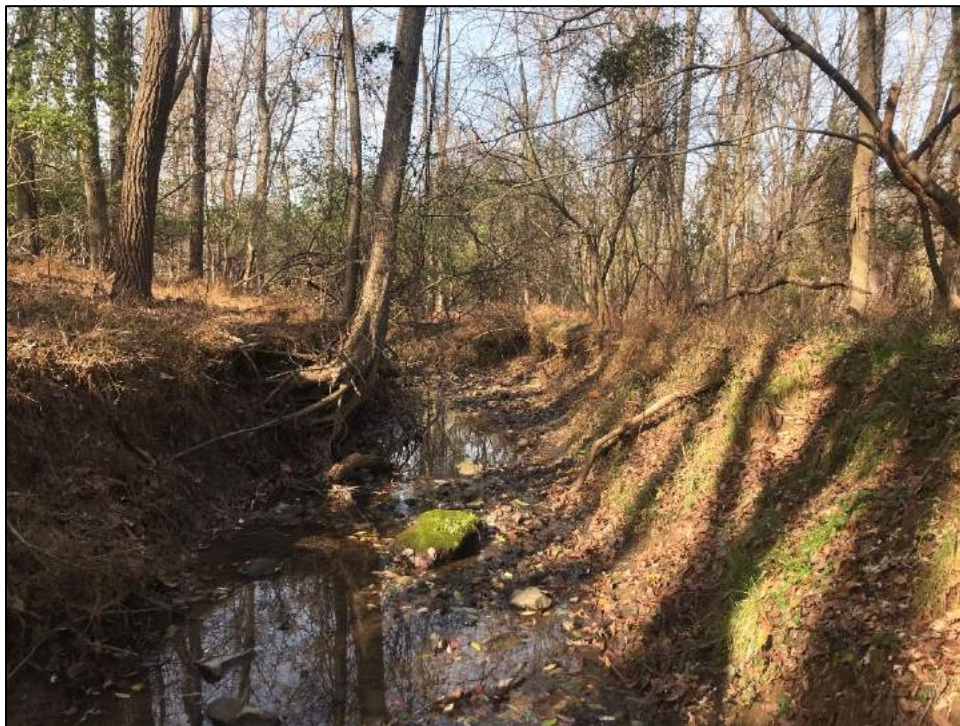
Photo 18: Reach 13, looking downstream near utility easement, 4' actively eroding banks. The riparian area contains a high concentration of invasive species.

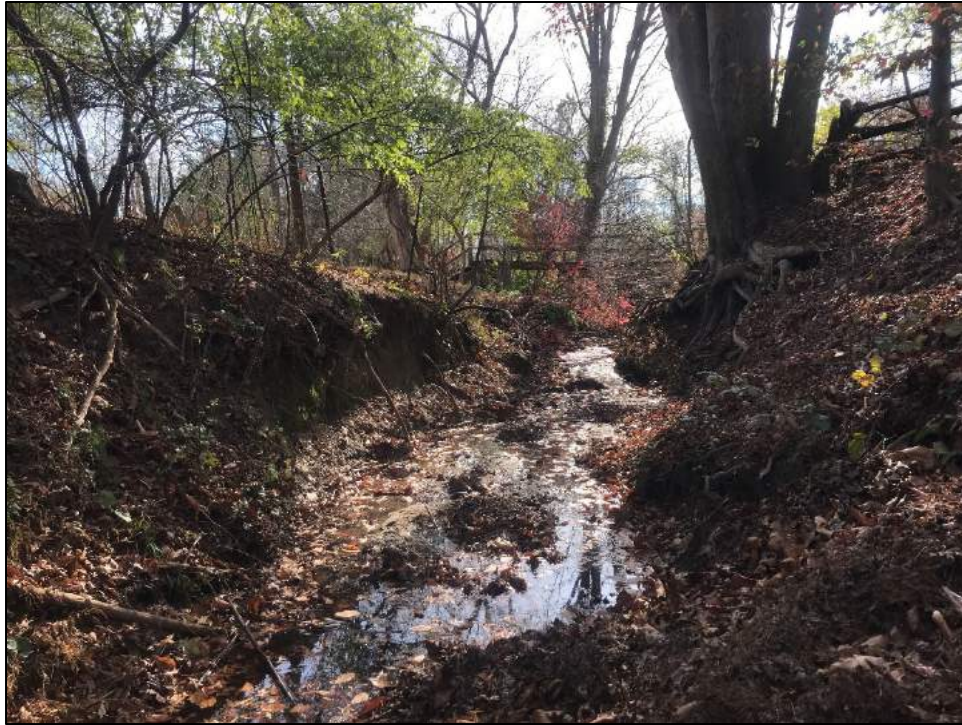
Photo 19: Reach 14, looking downstream near Tamar Drive, 4' actively eroding bank. The riparian area contains a high concentration of invasive species.

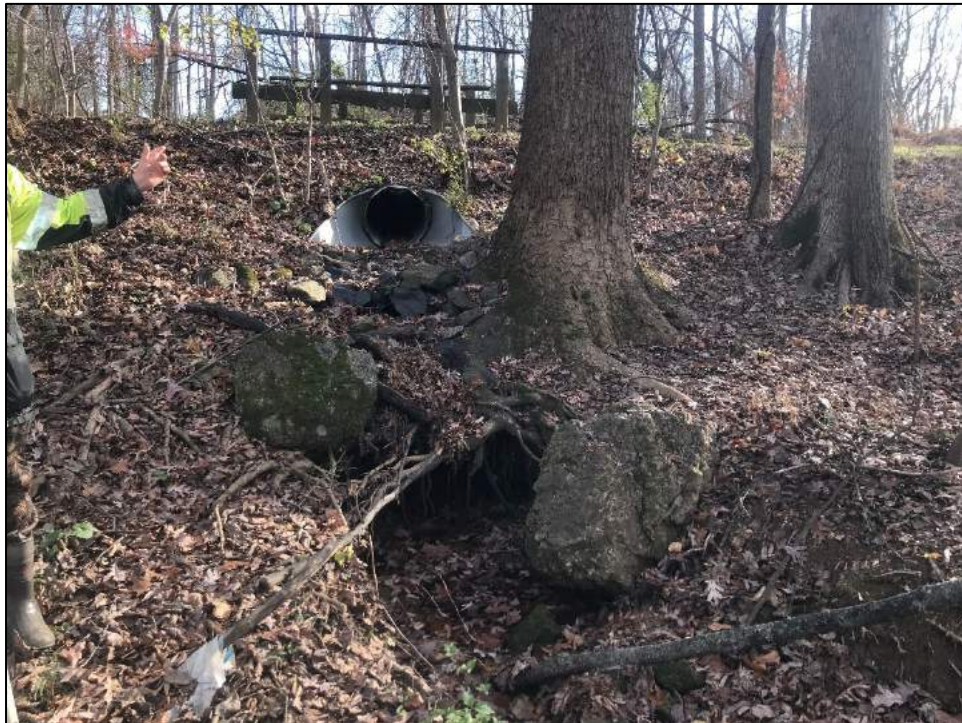
Photo 20: Reach 15-2, looking upstream near culvert under a pedestrian path, 2' head cut that is beginning to undercut a tree.

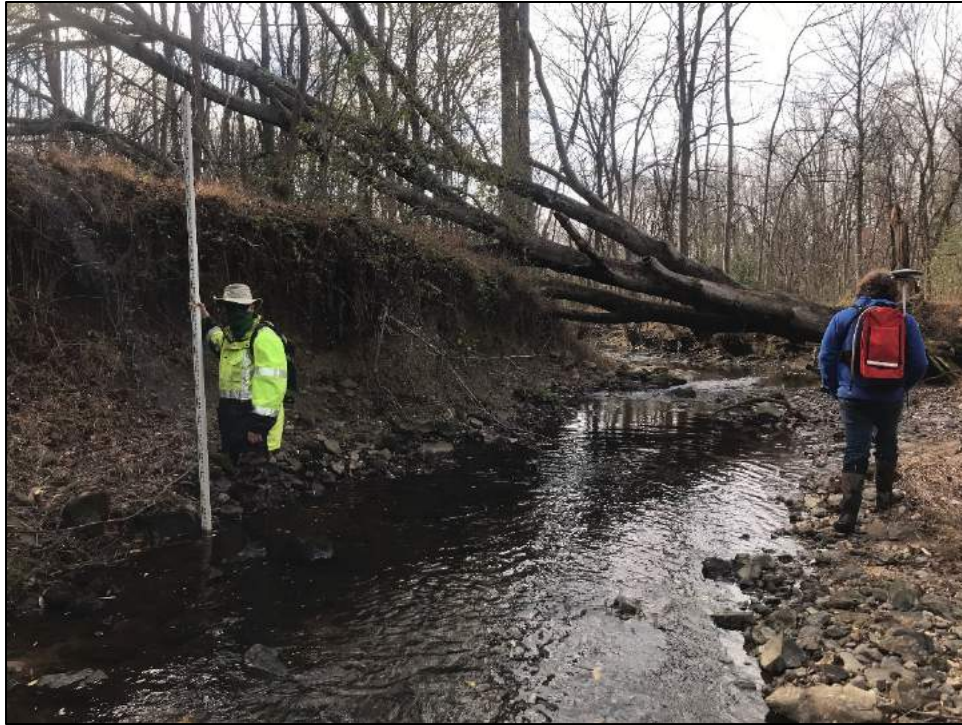
Photo 21: Reach 15A, looking downstream near confluence with Reach 16, 8' actively eroding bank and large fallen tree.

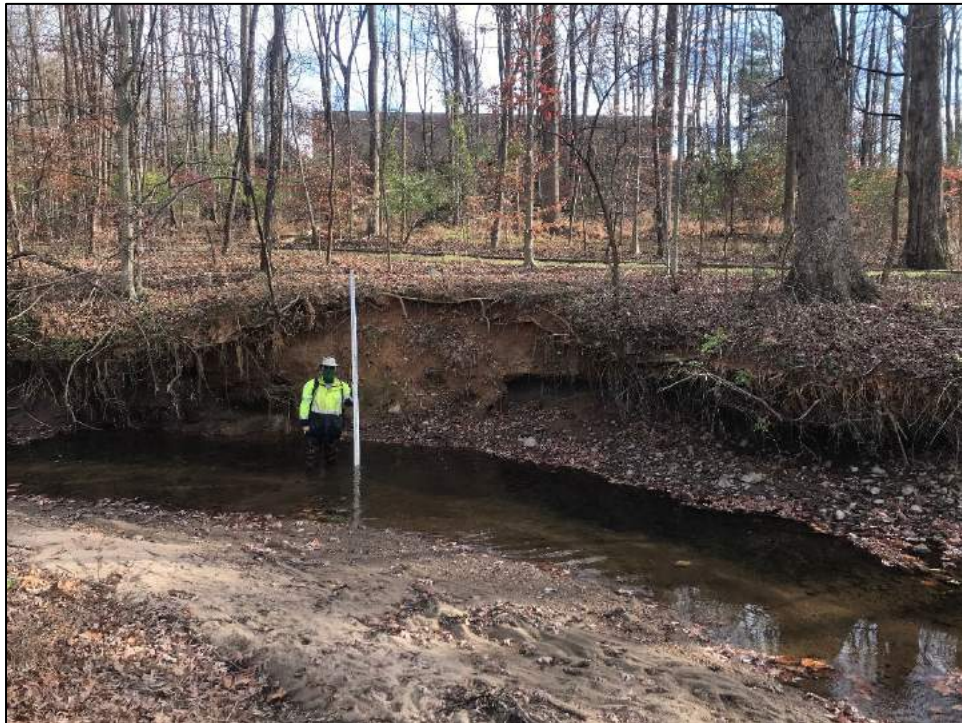
Photo 22: Reach 15B, looking upstream near Oakland Mills Rd, 9' actively eroding bank undercutting large tree

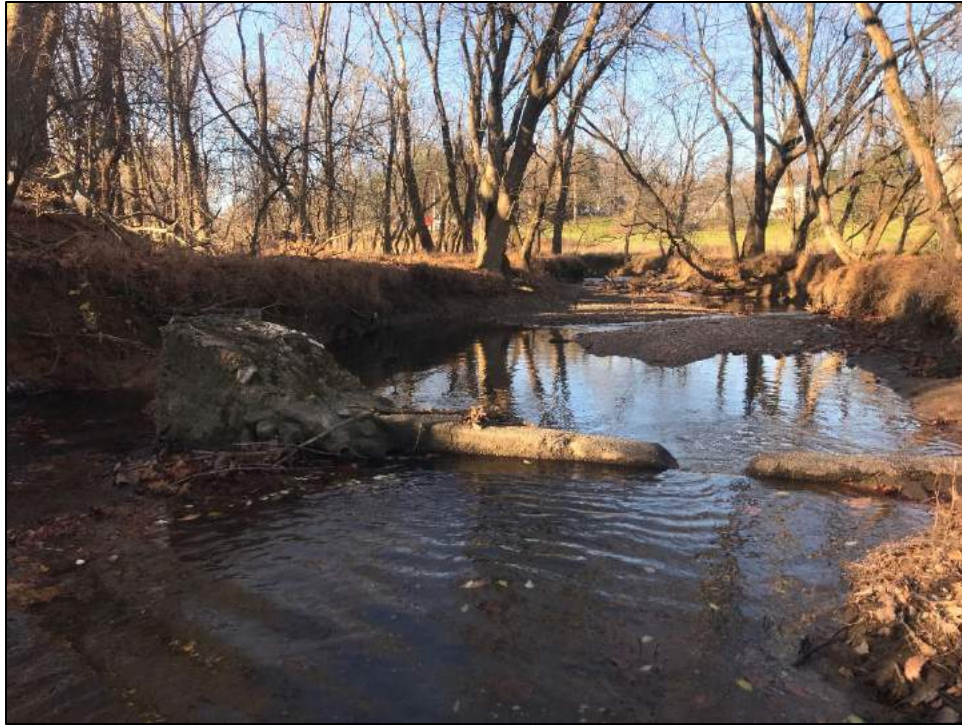
Photo 23: Reach 15C, looking downstream near Drowsy Day Drive, 4' actively eroding bank with exposed sewer line and over-widened channel.

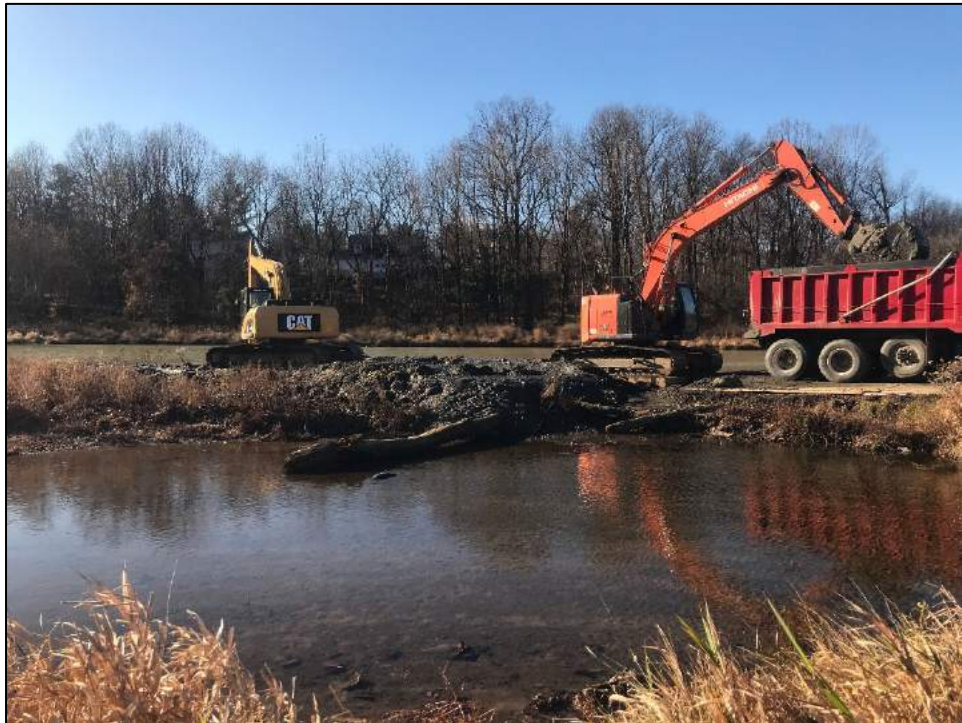
Photo 24: Reach 15C, looking downstream pond that ties into Lake Elkhorn, the pond is routinely dredged due to the high sediment load.

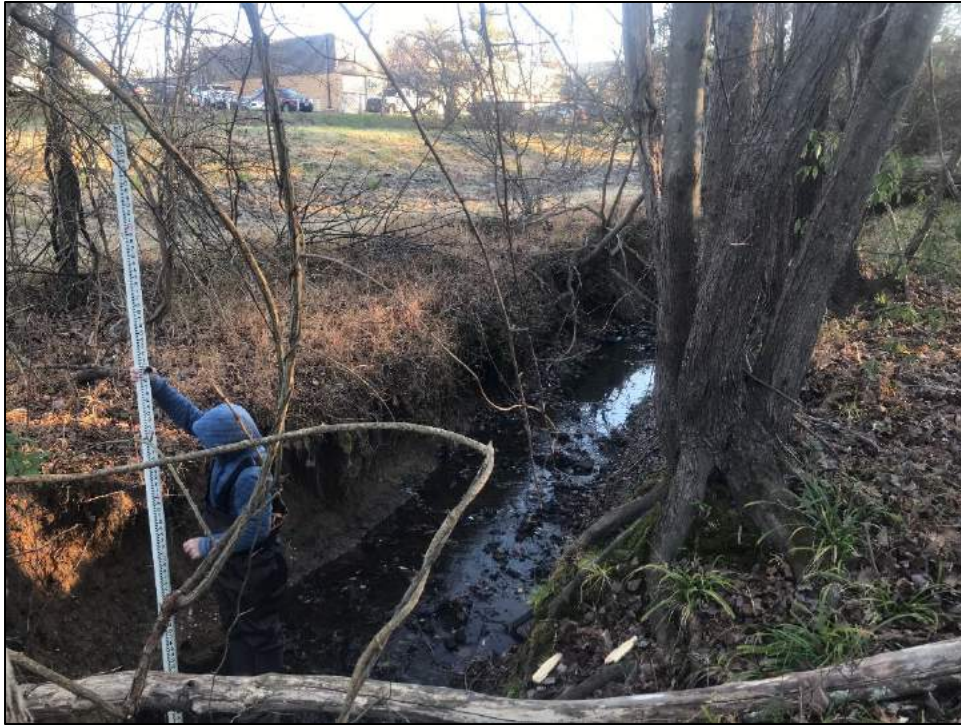
Photo 25: Reach 16, looking upstream near the confluence with Reach 15A, 4' eroding banks with minimal riparian vegetation.

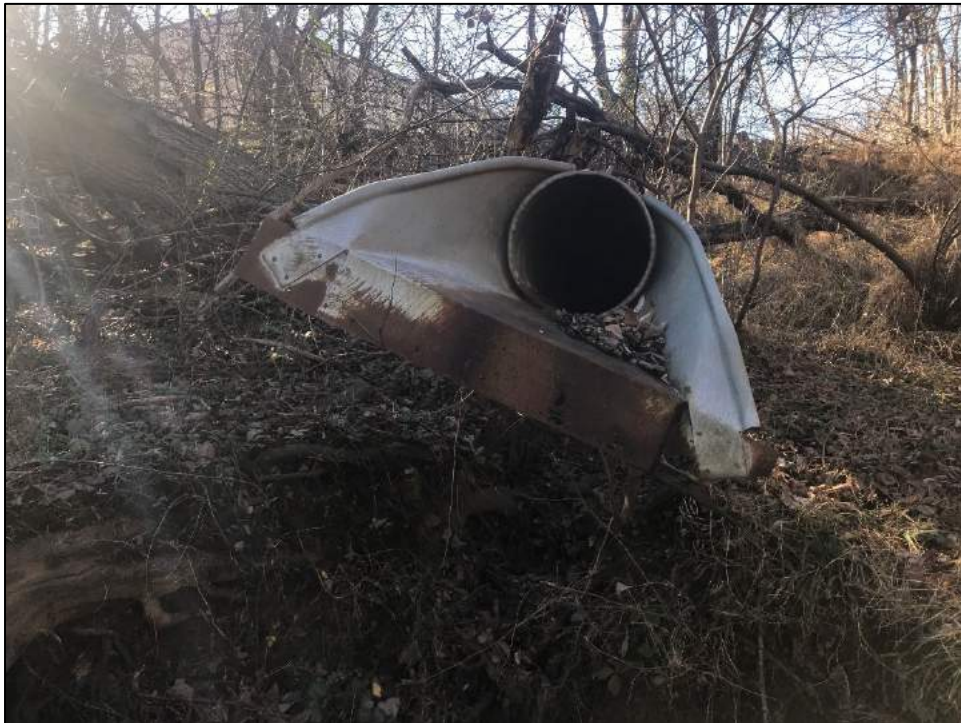
Photo 26: Reach 17, looking at outfall near Dobin Rd, the pipe has broken and is disconnected from the reach.

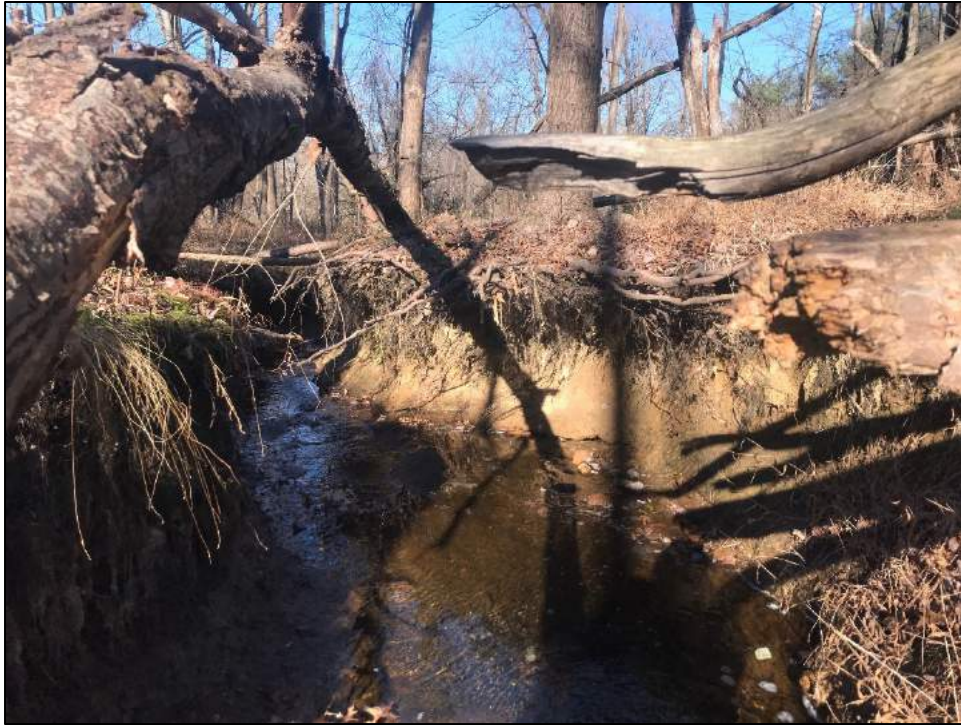
Photo 27: Reach 17, looking downstream near confluence with Reach 18 , 3' actively eroding bank.

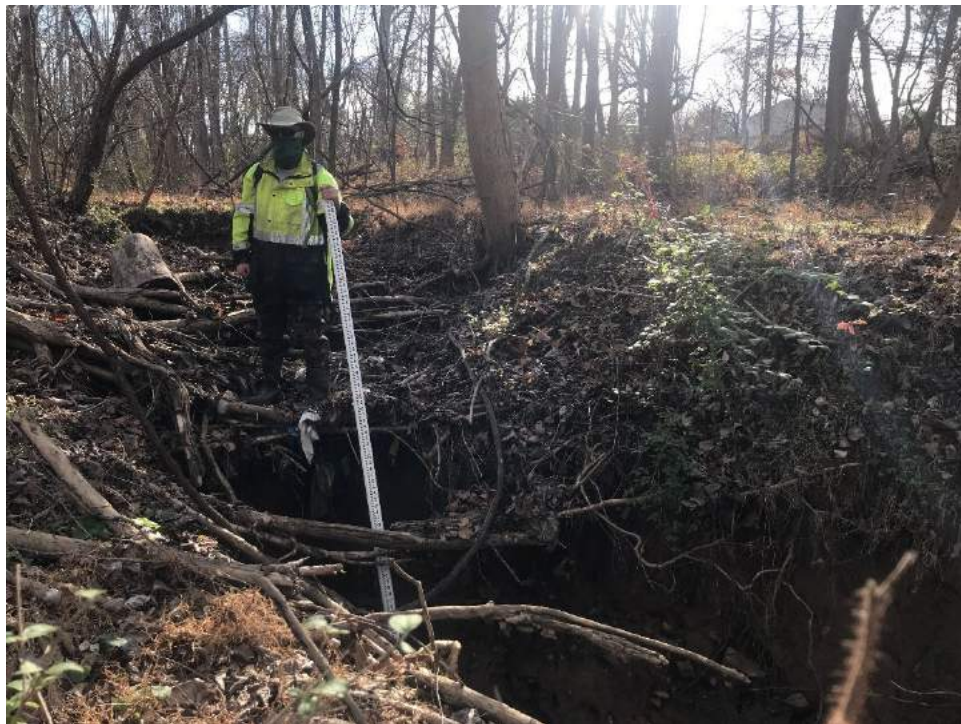
Photo 28: Reach 20, looking upstream near Oakland Mills Rd, 9' head cut and actively eroding banks.

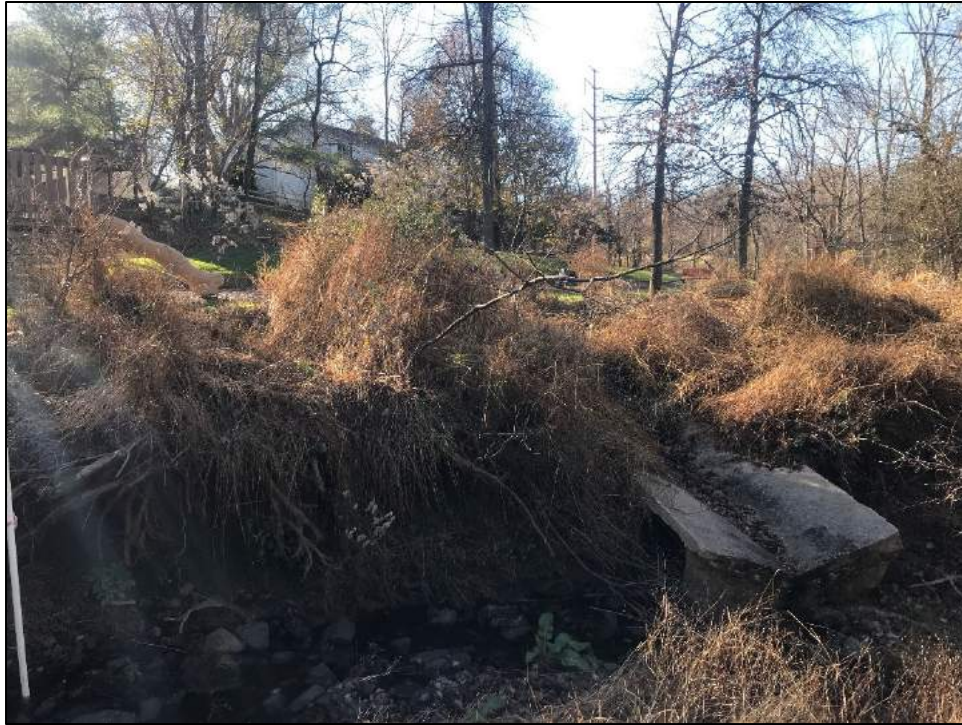
Photo 29: Reach 21A, looking at concrete swale near DeerPasture Dr, swale is disconnected from the stream and near failure.

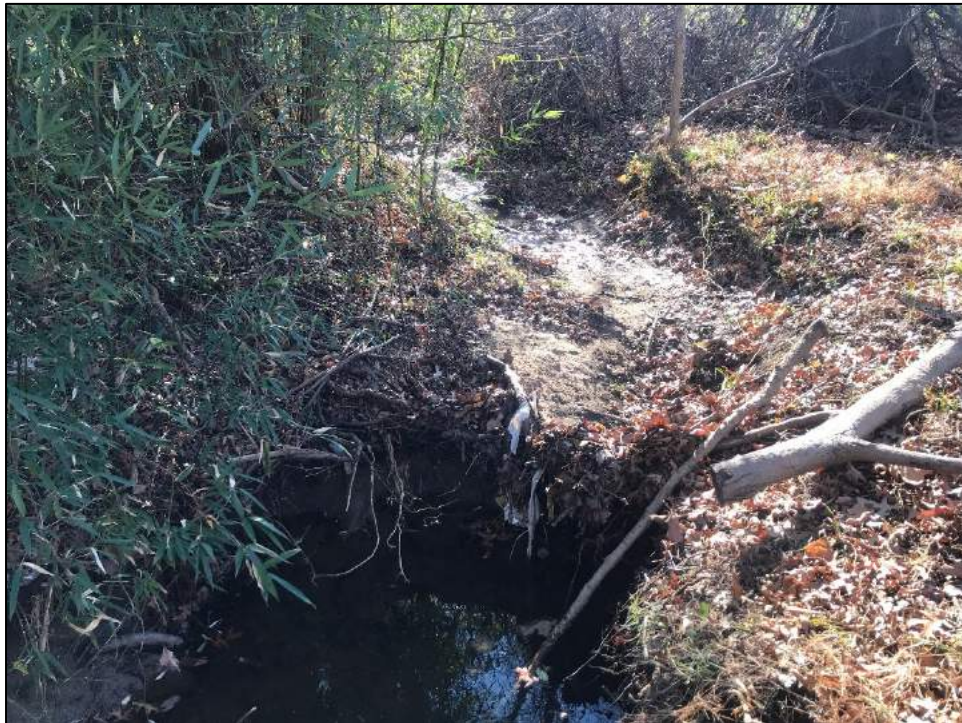
Photo 30: Reach 22, looking upstream near DeerPasture Dr, 3' head cut. The riparian area contains a high concentration of invasive species.

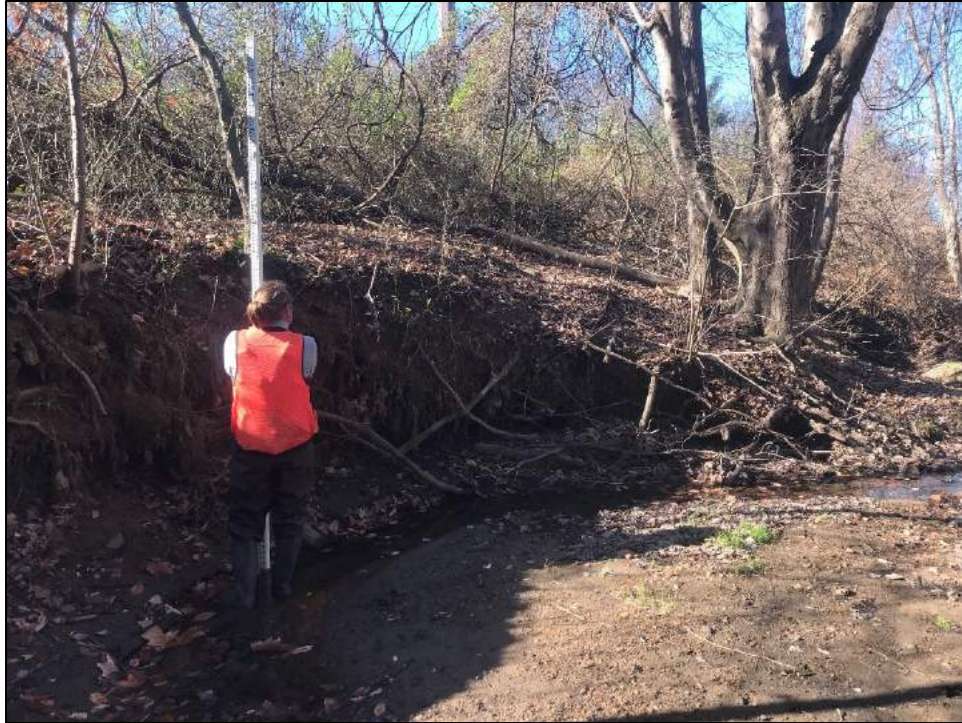
Photo 31: Reach 23, looking upstream near Hourglass Place, 6' eroding banks.
